# Failure Analysis of Steam Generator Tubes

*Gonzalo Diego and Susana Merino*

**Keywords:** steam generator (SG), denting, intergranular stress corrosion cracking (IGSCC), alloy 800, steam generator maintenance

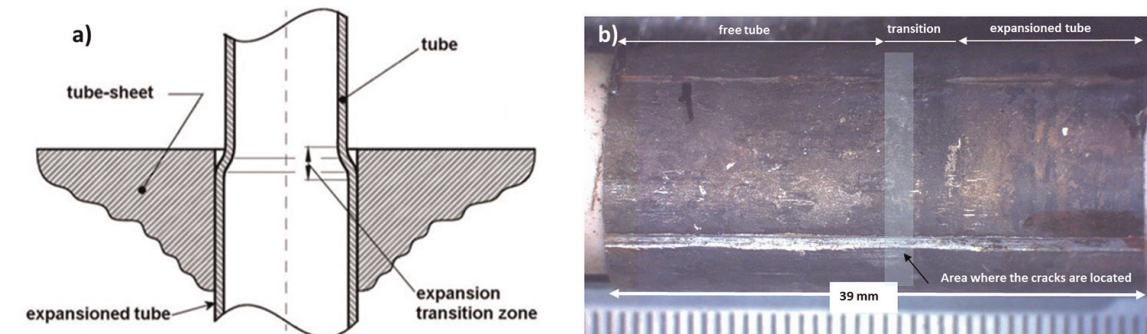
Circumferential cracks and denting were detected by Eddy’s current technique before the extraction in the expanded transition zone. Three different areas were identified for subsequent tests: free tube, transition zone, and expanded zone (**Figure 5a**). Zero is also marked for recording observations collected along the tube perimeter.

Multiple circumferential small cracks separated by ductile ligaments in an area of 5 mm width are shown in **Figure 5b**. These cracks were located at 3 mm from the last contact point between the tube and the tube sheet. Damage as “wastage,” pitting or other has not been detected. Different color is observed among these areas. The expanded region shows a red coloration (tube sheet contact) while the transition zone presents a dark gray color because this area has been covered by sludge.

**Figure 5.** a) As-reception segment tube extracted in the area of the sketch. b) Image analysis to detect the expansion end of the tube by stereoscopy microscopy.

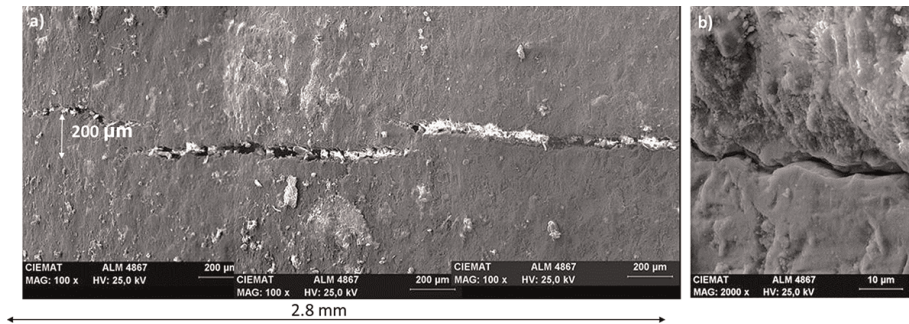
**Figure 6a** shows the cracks detected on the OD side of the tube. Cracks have a circumferential orientation with corrosion deposits and they were detected in an area around the tube located above the last point of contact between the tube and tube sheet. The highest density of the cracks was located at 5 mm of this last point. **Figure 6b** shows the intergranular morphology of the cracks at high magnification and the aspect of the corrosion deposits on the tube surface. EDX analyses show important amounts of Na, Si, S, and Cl in these areas. Also, the presence of Cu and traces of Pb and Zn were also detected in five analyses.

**Figure 6.**  
a) Circumferential cracking on OD transition zone. b) Detail of the intergranular morphology of the cracks.

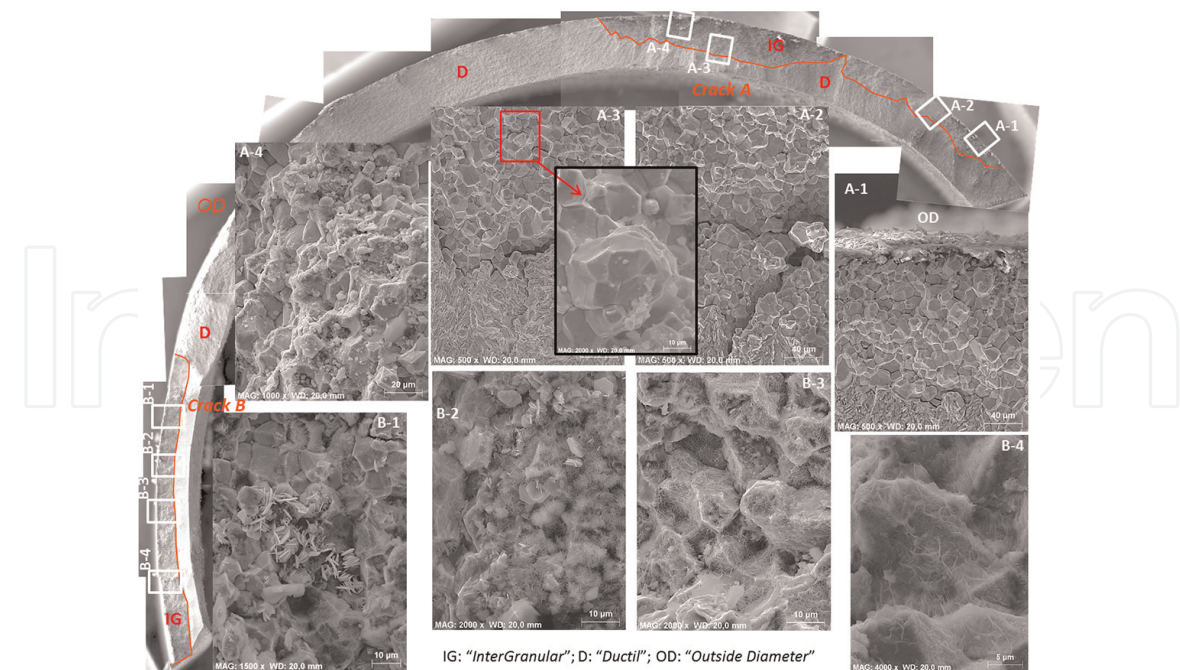
Morphology of the fracture is shown in **Figure 7**. Crack A presents an intergranular morphology with several ductile ligaments. Maximum depth of the intergranular crack was 937 mm, 82% of the tube thickness. Crack B, also of intergranular

**Figure 7.**  
*Fracture surface with details of the intergranular crack and deposits morphology (A and B).*

morphology, is not complete, due to the initial cut to obtain the two halves. Maximum depth of this crack B is 55% of the tube thickness.

Intergranular morphology of the two fractures showed some different aspects between them (**Figure 7**). Fracture surface of crack B was covered by a continuous gelatinous film, while the fracture surface of crack A showed corrosion deposits only in the initial area, near the outer surface, while the remainder of the fracture was completely clean.

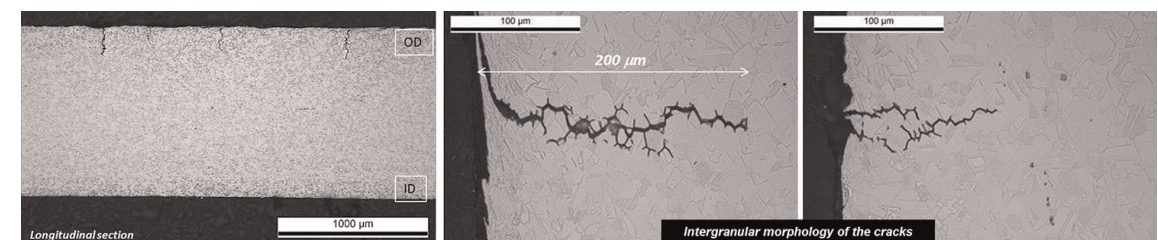
Metallographic characterization of selected cracks by stereoscopy microscopy was prepared in the thickness plane of the other half segment tube. **Figure 8** shows the morphology of the crack in the metallographic samples. The maximum depth detected

**Figure 8.**  
*Intergranular cracks in metallographic samples.*

was 210  $\mu\text{m}$ , being in all cases of intergranular morphology. In one of them, it can be observed that the crack initiation is parallel to OD surface, possibly due to the existence of a hardened surface (shot peening process). In other areas, the cracks propagated with normal orientation to OD surface.

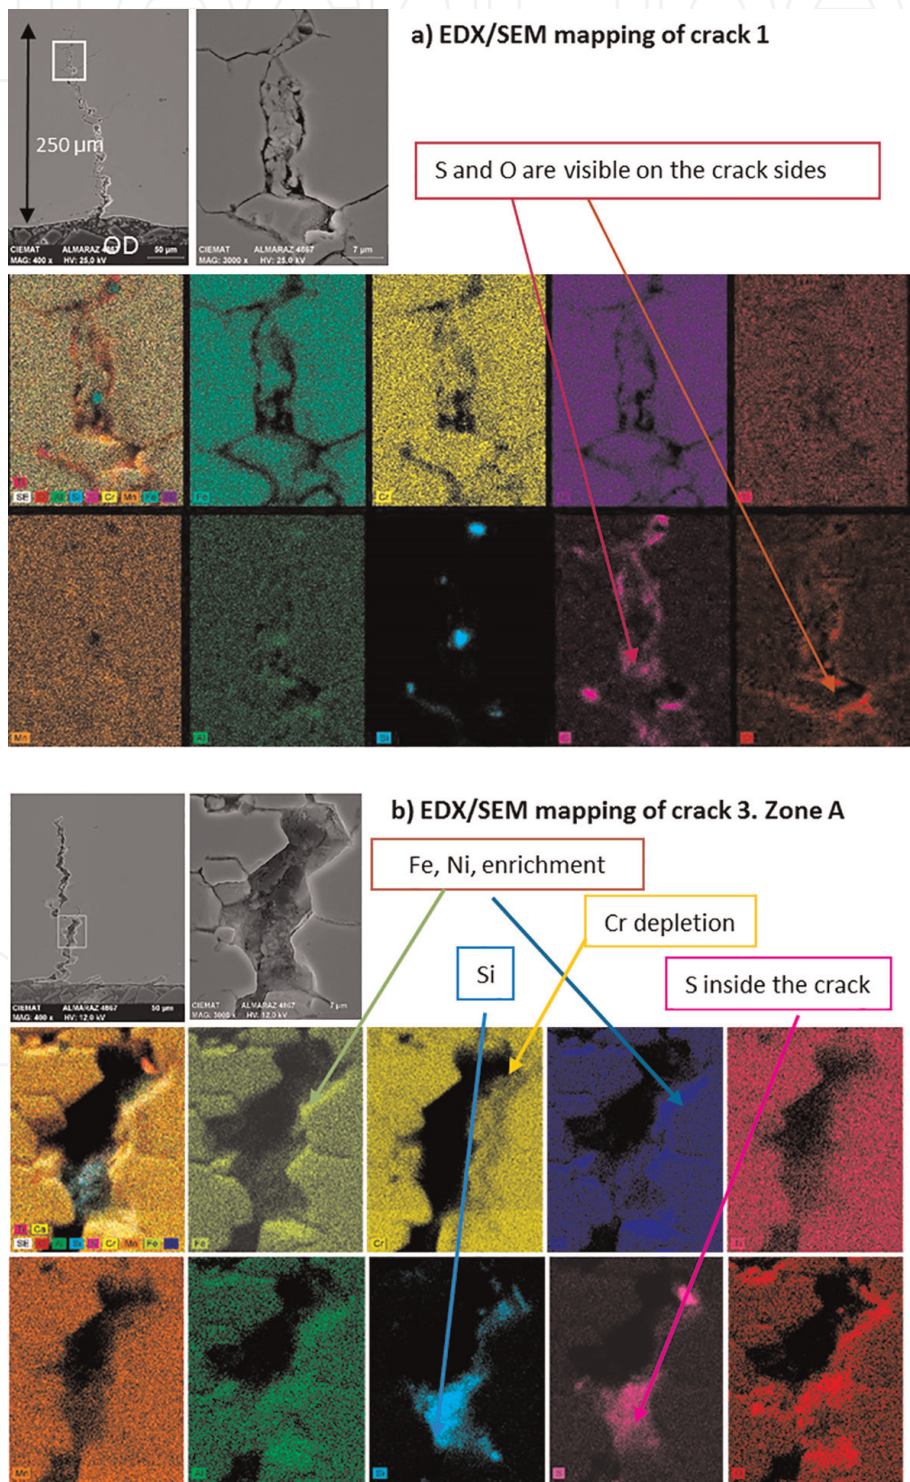
**Figure 9a** shows the sulfur distribution inside the cracks by x-ray mapping. In some cases, S seems to be associated with Ni or Cu and not with oxygen. It is very possible that these elements are in sulfide form. A Fe and Ni (Cr depleted) rich layer

**Figure 9.**  
a) EDX/SEM mapping of crack 1. b) EDX/SEM mapping of crack 3.

can be observed in **Figure 9b**. Besides, Si and oxygen have been detected in very internal areas of the crack. Also, the presence of S is remarkable in this area.

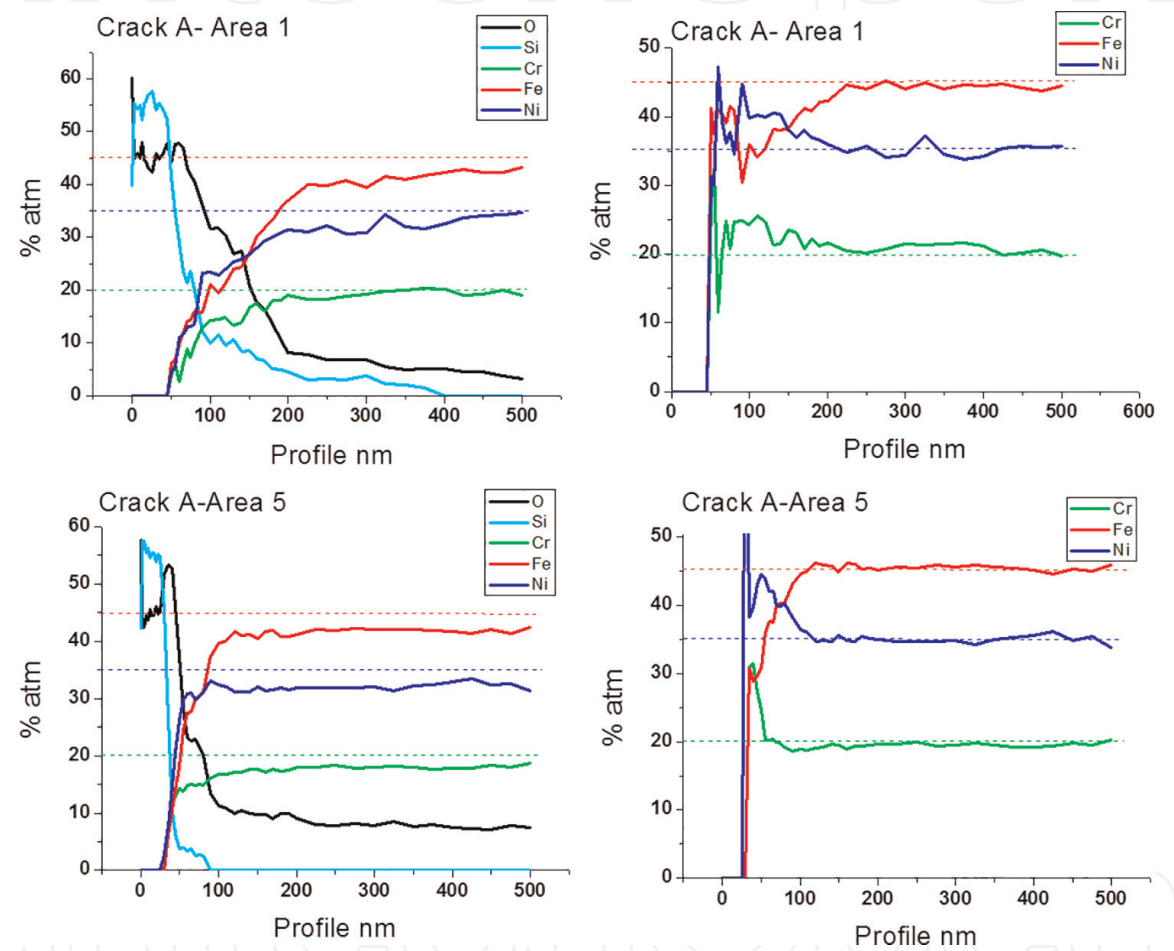
**Figure 10.**  
Auger profile concentration for O, Si, Cr, Fe, and Ni and Cr, Fe, and Ni. Areas 1 and 5 of crack A.

Concentration profiles at crack A (area 1), show a thicker silicate layer around 400 nm. This point is the closest to OD. In the other points, far from OD (area 5), the silicate layer is thinner (<100 nm). Ni enrichment is always detected at the five points of the analyses. Fe is always depleted in all cases, even though in the first layers this depletion is less pronounced. Cr is enriched in the first nm and after it is stabilized with a concentration corresponding to the base material or slightly depleted.

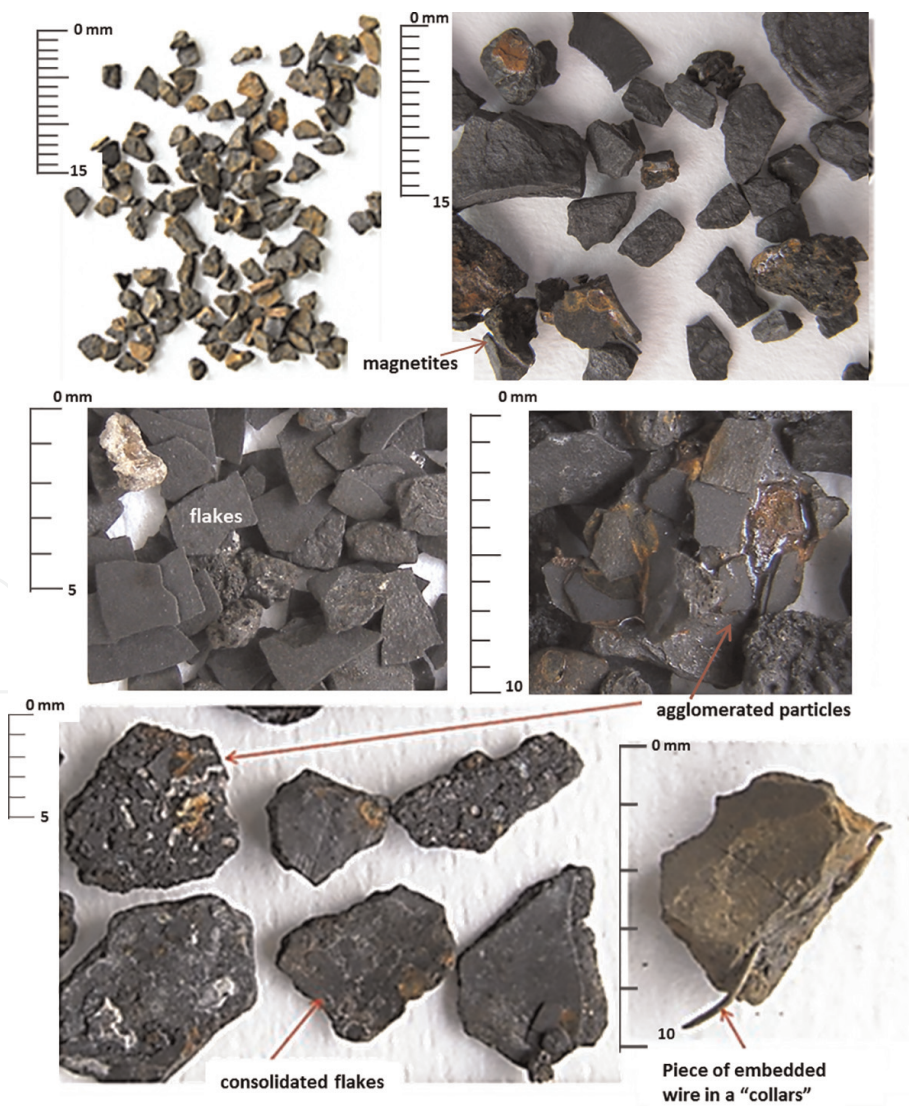
After sub-samples separation, M (magnetite layered), C (collars), and F (flakes) pieces were identified visually to characterize macroscopic features such as size, shape, and color. **Figure 11** shows macroscopic photographs of deposit sub-samples. Typical magnetite pieces were present as small “gravel,” generally on the order of a few millimeters in length. The colors of these pieces were grey with areas of orange tone and showed geometries and curvature compatible with the triangular shape of the space between tubes in SG tube sheet (**Figure 12**).

**Figure 11.**  
*Different morphology of deposits collected from steam generator.*

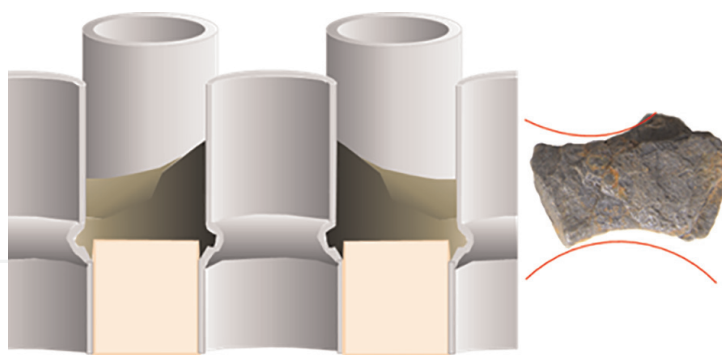
**Figure 12.**  
*Individual particle from tube-sheet SG. Dimensions fit the space between the tubes of tube sheet.*

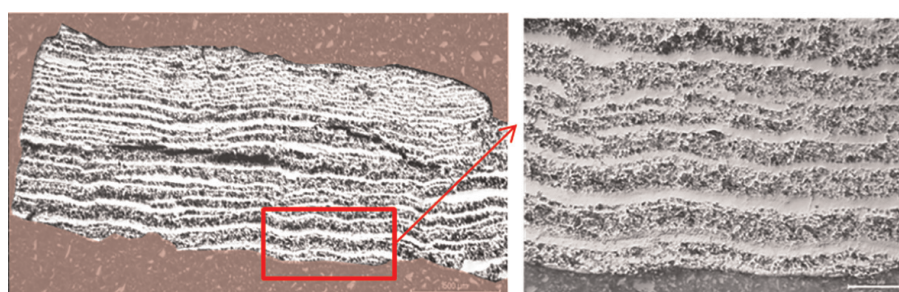
**Figure 13.**  
*Cross-section of magnetite layered particle. Optical and SEM images.*

Magnetite layered pieces of several mm of thickness presented very high hardness values (876 Hv maximum). On the other hand, “flakes” present moderate hardness values (533 Hv maximum). “Collars” showed hardness slightly lower and heterogeneous values.

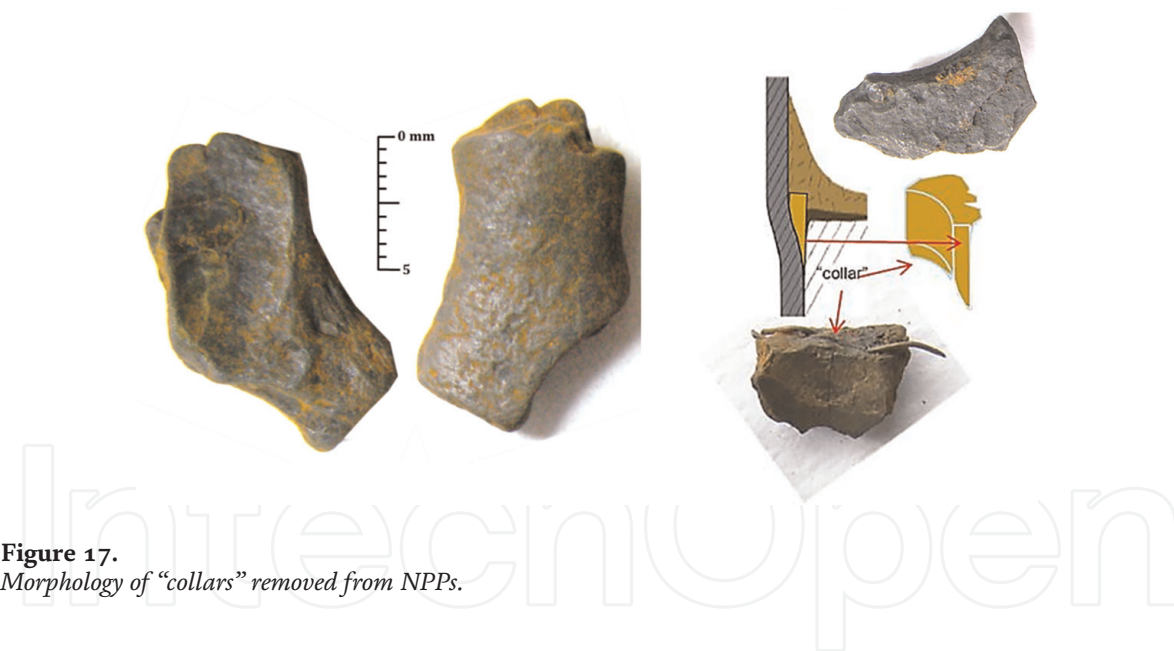
As discussed at the start of this section, “collars” pieces were detected Spanish NPPs (**Figure 17**). Cross-sections of these samples are formed by a number of metallic inclusions embedded in a matrix of Al and Si species (**Figures 18 and 19**). These last elements were enriched preferably near the interface with SG tube surface. Si/Al ratio is higher when the silicates are the binding agents.

**Figure 17.**  
*Morphology of “collars” removed from NPPs.*

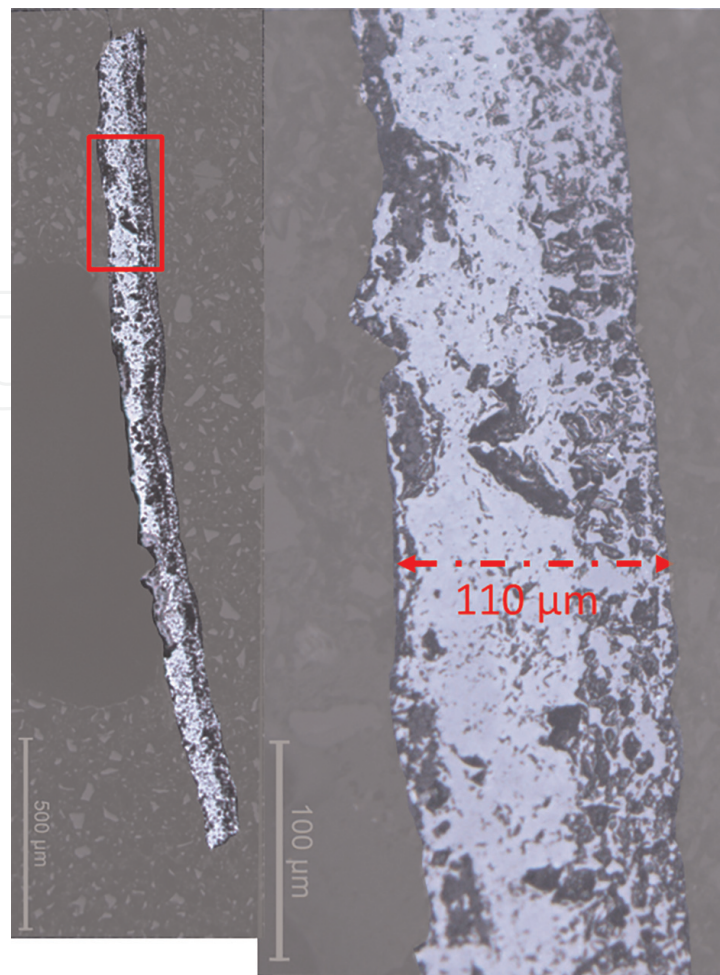
Normally, flakes are formed by an inner layer in contact with the tubing surface and an outer layer with high porosity (Figure 20).

**Figure 20.**  
Cross-section of “flake.”

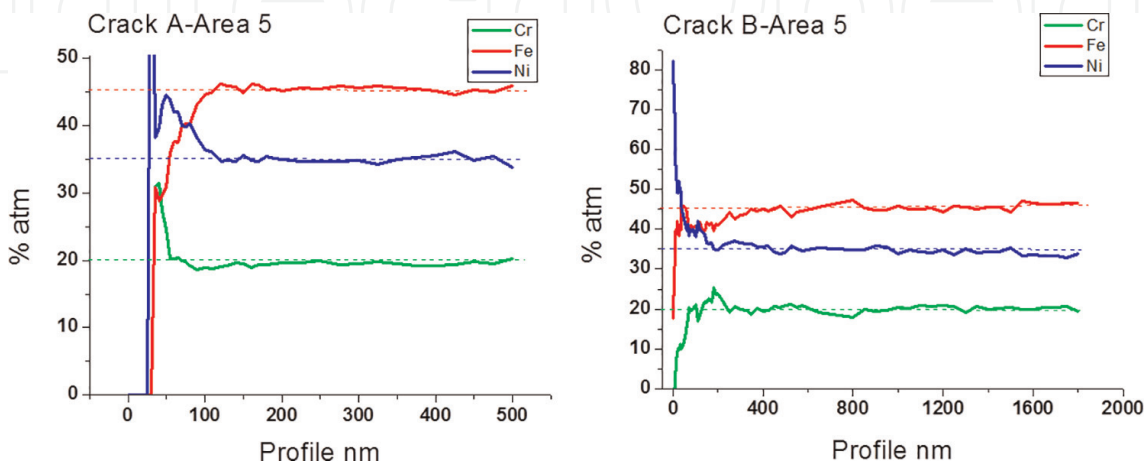
If we compare these results with the concentration profiles obtained at the bottom of cracks A and B (**Figure 21**), we observe that the main difference between these curves and those of the laboratory sample is the existence of nickel enrichment in the latter, which, as shown in **Figure 23**, is the typical trace left by alkaline environments.

Therefore, we can conclude that the cracks have been formed in a neutral or slightly alkaline environment. Alkaline environments with pH> 10 can be discarded due to the presence of silicates. Sulfur presence would suggest acidic environments, although this evidence is not fully conclusive in all performed analyses. However,

**Figure 23.**  
Concentration profiles obtained in the segment of the tube on the fracture surface of cracks A and B in the area near the bottom of the crack.
