# Enhancing photovoltaic module sustainability: Defect analysis on partially repaired modules from Spanish PV plants

M.B. Nieto-Morone<sup>a,b,\*</sup>, F.G. Rosillo<sup>a</sup>, M.A. Muñoz-García<sup>b</sup>, M.C. Alonso-García<sup>a</sup>

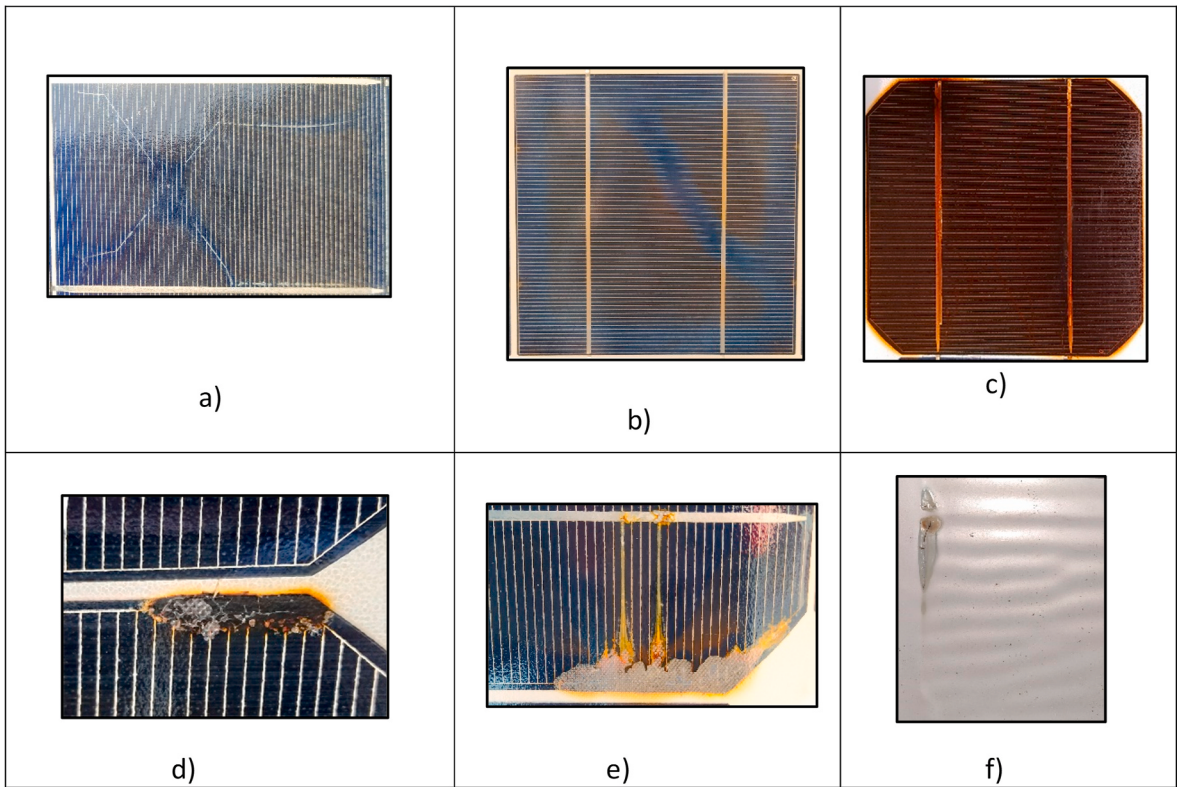
Fig. 1 shows some images from the visual inspection of the PV modules. The failures are identified according to the classification suggested by Ref (Kontges et al., 2018)

The results show that the modules exhibit optical degradation due to delamination and discolouration of the encapsulation. Delamination at the cell interface can be classified into two main types: front-side and backside delamination. Backside delamination usually appears as surface bubbles, which could cause the formation of hotspots, leading to a decrease in the system's energy output. In contrast, front-side delamination displays a distinct grey appearance when it arises at the cell interface (Meena et al., 2020).

**Fig. 1.** a) Snail trails. b) Brownd EVA and broken cell. c) Burnt cell. d) and e) Delamination and corrosion as a consequence of EVA degradation. f) Bubbles formation, cracking and burn in the backsheet.

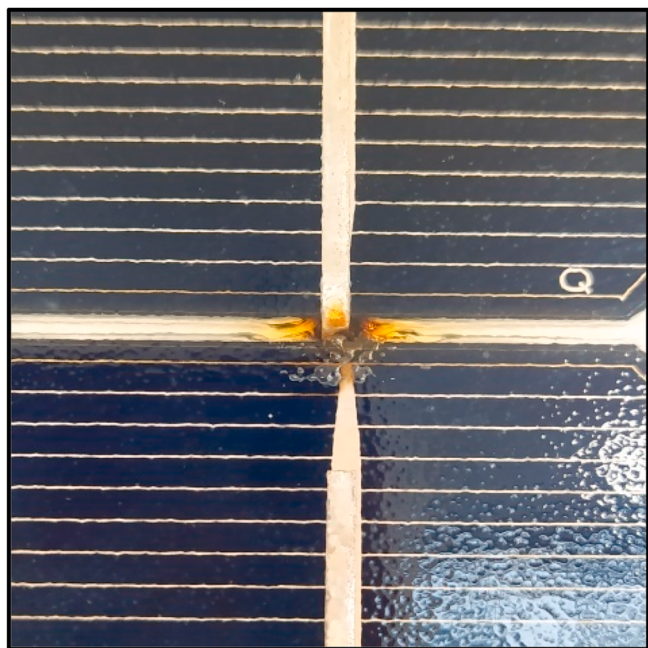
Fig. 3 illustrates the presence of trapped moisture alongside corrosion and oxidation in the metal grids surrounding the solder joint. This effect is called Moisture-induced degradation, MID (Jeffries et al., 2021; Kim et al., 2013; Peike et al., 2013). This failure is mainly attributed to the dissolution of lead and tin in the presence of moisture and acetic acid, which is generated by photo-degradation of EVA encapsulant and cannot leave the module (Kraft et al., 2015; Oreski et al., 2019). The degradation mechanism of EVA starts with deacetylation followed by an oxidation and fragmentation of the main chain of vinyl acetate. (Czanderna, 1996) (see Fig. 3).

Fig. 3. Image of moisture-induced degradation of EVA and corrosion within the metal grids.

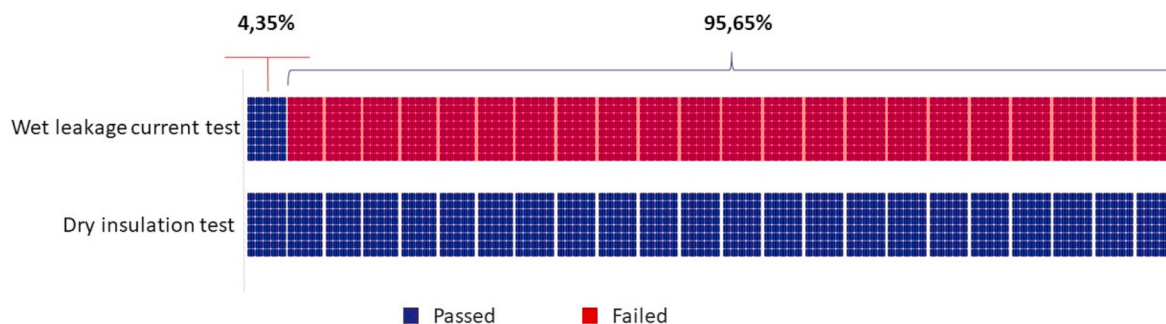
concluded that when backsheet absorbs some water, the resistance decreases. This conclusion is coincident with our findings, which indicate that PV modules can pass the dry insulation test but fail the wet leakage

current test, as highlighted in Fig. 4, which leads to a safety key issue. These results are consistent with the evidence found by visual inspection, where it was possible to detect micro-cracks in the backsheet

and/or exposed welds. Backsheet cracks act as pathways for ultraviolet radiation, oxygen and moisture ingress. These elements can lead to the degradation of encapsulating materials, erosion of metallisation, and significant declines in insulation resistance (Nordmann et al., 2014).

All modules analysed exhibit exposed welds on the backsheet (due to bus bar interruption repair). This condition is not a failure due to the degradation of the module itself but rather a result of the subsequent partial repair, which caused the insulation to fail, making electrical isolation impossible. To fix the insulation of these modules, it is necessary to continue with the backsheet repair, sealing the exposed solder joints and re-testing the modules for wet leakage current.

Fig. 4. Of the 23 PV modules evaluated, all 23 passed the dry insulation test, while only one passed the wet leakage current test.

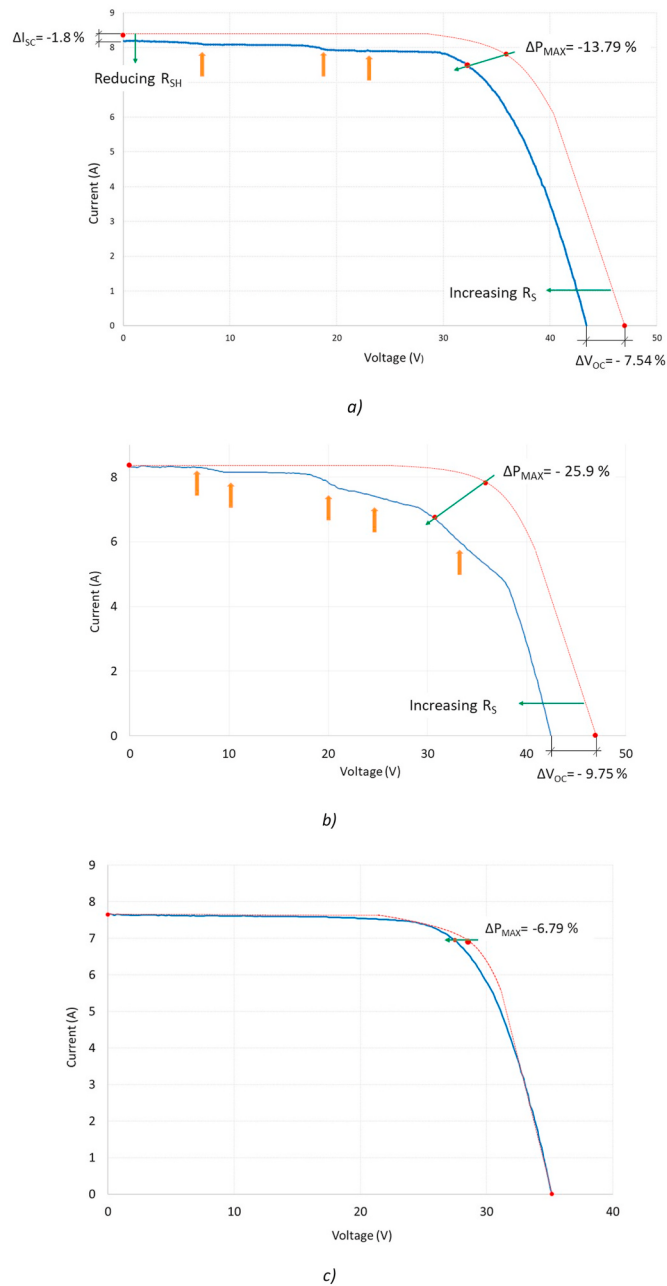
Fig. 5 a, b and c illustrate the degradation in  $P_{max}$ ,  $V_{oc}$ , and  $I_{sc}$  due to increased series resistance, low shunt resistance and reduced fill factor for a selection of modules.

Fig. 5a shows an I-V curve indicating a degradation in the electrical parameters from their nominal values. The decrease in  $I_{sc}$  and a substantial reduction in  $P_{max}$  and fill factor (FF) can be attributed directly to electrical mismatches between cells in the photovoltaic module. The electrical mismatches may include disconnected cells, interrupted string interconnection ribbons or busbars.

Metal grid corrosion, optical degradation, and Potential Induced Degradation (PID) caused by moisture ingress are the leading causes of series resistance losses and, as a result, power degradation. This degradation caused by moisture ingress is called Moisture induced degradation, MID (Segbefia et al., 2021a, 2021b). Fig. 5b is an I-V curve of another module of type C showing this phenomenon. In a standard photovoltaic system, there is usually a high voltage difference between the active circuit and the module frame at both ends of the string. This disparity can lead to the occurrence of leakage currents within the module assembly, potentially resulting in a reduction in the efficiency of PV modules (Luo et al., 2017). PID is a failure mechanism that occurs in operational PV modules. It is a crucial factor triggered by external conditions that tend to accelerate the degradation process when exposed to hot and humid conditions, resulting in significant power loss and substantial degradation. The PID effect induces cell shunts, leading to the degradation of  $V_{oc}$  and FF. This particular MID effect will be detected with electroluminescence characterisation in section 3.4.

**Fig. 5.** I-V curves of a set of modules showing degradation in  $P_{max}$ ,  $I_{sc}$  and  $V_{oc}$ . a) Type C module exhibits a decrease in  $I_{sc}$ ,  $V_{oc}$  and  $P_{max}$ . b) The type C module shows a decrease in  $V_{oc}$  and  $P_{max}$ , and the change in slope indicates PID (Kontges et al., 2018) c) The type B Module presents a reduction in  $P_{max}$ .

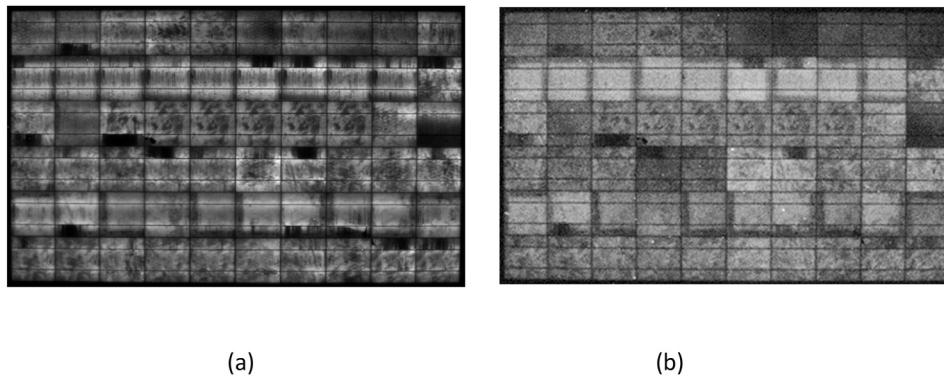
impact of moisture penetration through microcracks and its degradation effects elsewhere. Our findings align with other reports, as evidenced by (Kajari-Schröder et al., 2012). It can be seen in Fig. 6 an example of this type of failure, the moisture-induced degradation, MID, explained in section 3.1.

**Fig. 6.** Electroluminescence images of m-Si taken under (a) Isc and (b) 10 % of Isc forward bias conditions exhibiting MID.

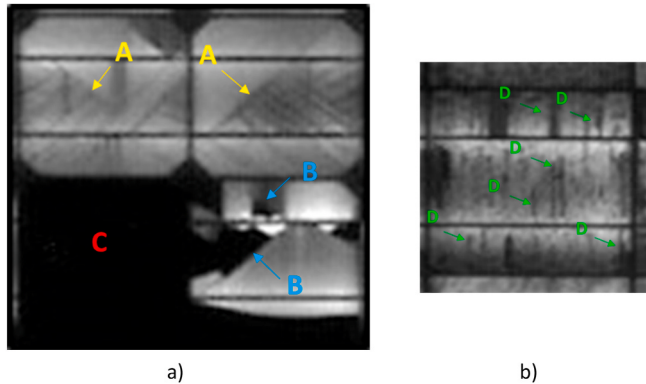
Some cracks do not interrupt the current flow, while others electrically insulate the region in the cell. The non-disruptive cracks have been denoted as "A", while the electrically insulated areas are indicated as "B" in Fig. 8. Although both images display cracks labelled as "A," they

exhibit different patterns. In photo a), the crack pattern is branched, while in photo b), it may be attributable to impacts on the module. The cell marked as "C" is entirely disconnected from the circuit and is bypassed because of a reparation. The "D" faults are broken fingers, which are similar to other cases documented in the literature and originate during soldering (Spertino et al., 2015).

**Fig. 8.** Different failures detected with EL. a) Dendritic or branched cracks denoted by "A". Deep cracks disconnecting a region in the cell denoted by "B". Disconnected cell denoted by "C". b) Broken fingers denoted by "D".

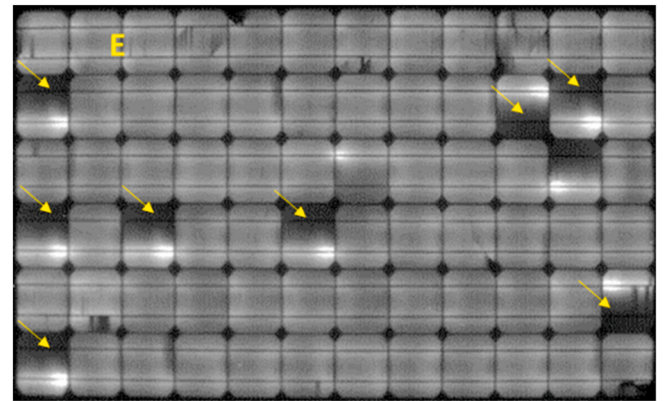
Inadequate soldering, thermomechanical stresses, or the presence of hot spots can damage or deteriorate the connecting ribbons between the solar cells or the busbars, resulting in a mismatch in the PV module's electrical parameters. Fig. 9 shows an EL image of a module exhibiting several examples of this failure.

**Fig. 9.** Several disconnected busbars in a module type C. Note that as one of the two busbars in each defective zone is active, then the current flows.

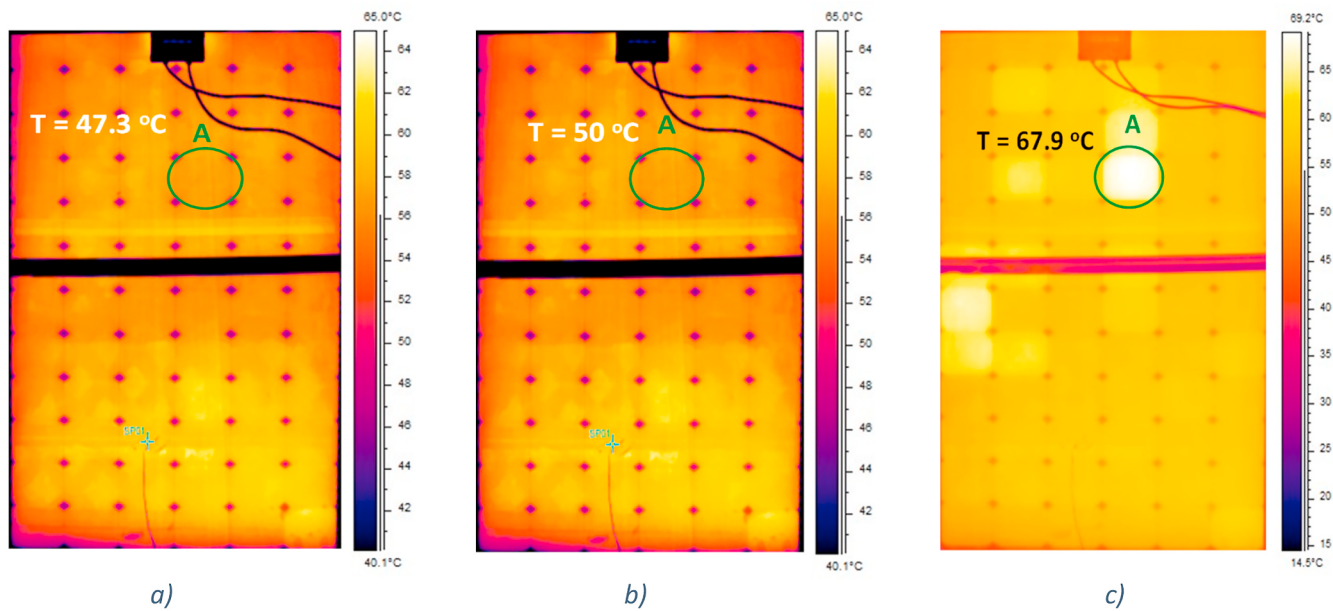
Fig. 10 presents the most significant temperature differences observed between operating near maximum point and short-circuit operating conditions were around  $17^\circ\text{C}$  in the marked area "A".

Under this categorisation, thermographic images revealed "strong hot spots" in a percentage of 4.35 % of the examined modules operating near their maximum power point, whilst 2.3 % presented strong hot spots during short-circuit operating conditions and 74 % displayed "light hot spots". In this last group, we found that 47 % had featured high temperatures in the junction boxes, attributable to the diode's activation and further energy dissipation. Furthermore, all photovoltaic modules in their operating point condition exhibited a temperature pattern that closely resembles the one described in (Ulrike et al., 2018), where the solar cells situated near the junction boxes typically operate at temperatures  $3^\circ\text{C}$  higher than those located in other parts of the cell matrix.

**Fig. 10.** Infrared thermographic images of a PV module operating in a) open circuit, b) near maximum power point, c) short circuit. The encircled region marked “A” corresponds to the maximum temperature area. Test conditions: Irradiance  $923 \text{ W/m}^2$ ,  $T_r = 20 \text{ }^\circ\text{C}$ .

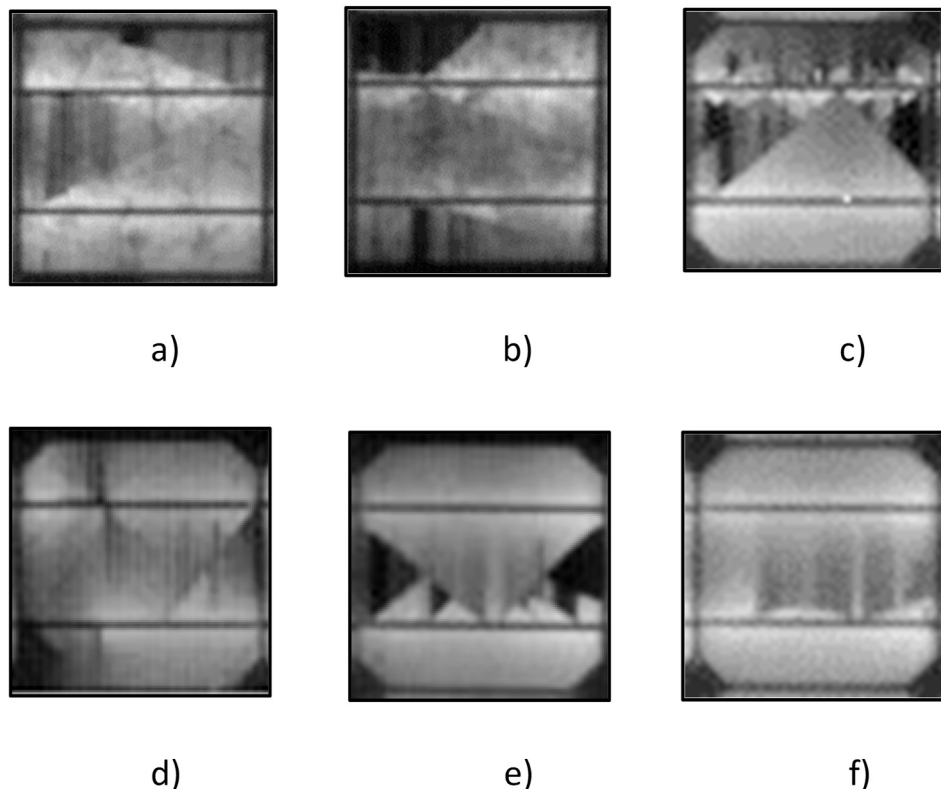
electroluminescence and classified them as multidirectional, diagonal, parallel, and perpendicular to busbars. These papers indicate that while the cracks may not cause cell disconnection, they can develop resistance to current flow when operated continuously. Additionally, the papers have determined that cracks parallel to the busbars are critical because they decrease the current flow (Dhimish et al., 2017; Kajari-Schröder et al., 2012). As shown in Figs. 8 and 11, our analysis revealed that the cracks in our study mainly allow current conduction, with the most

common direction of crack occurrence being diagonal (40.21 %), while cracks perpendicular or parallel to the busbars accounted for only 22.7 %.

**Fig. 11.** a), b), c), d), e) Diagonal cell cracks. a), c), e), f) Parallel and perpendicular. d), e) Multidirectional cell cracks.

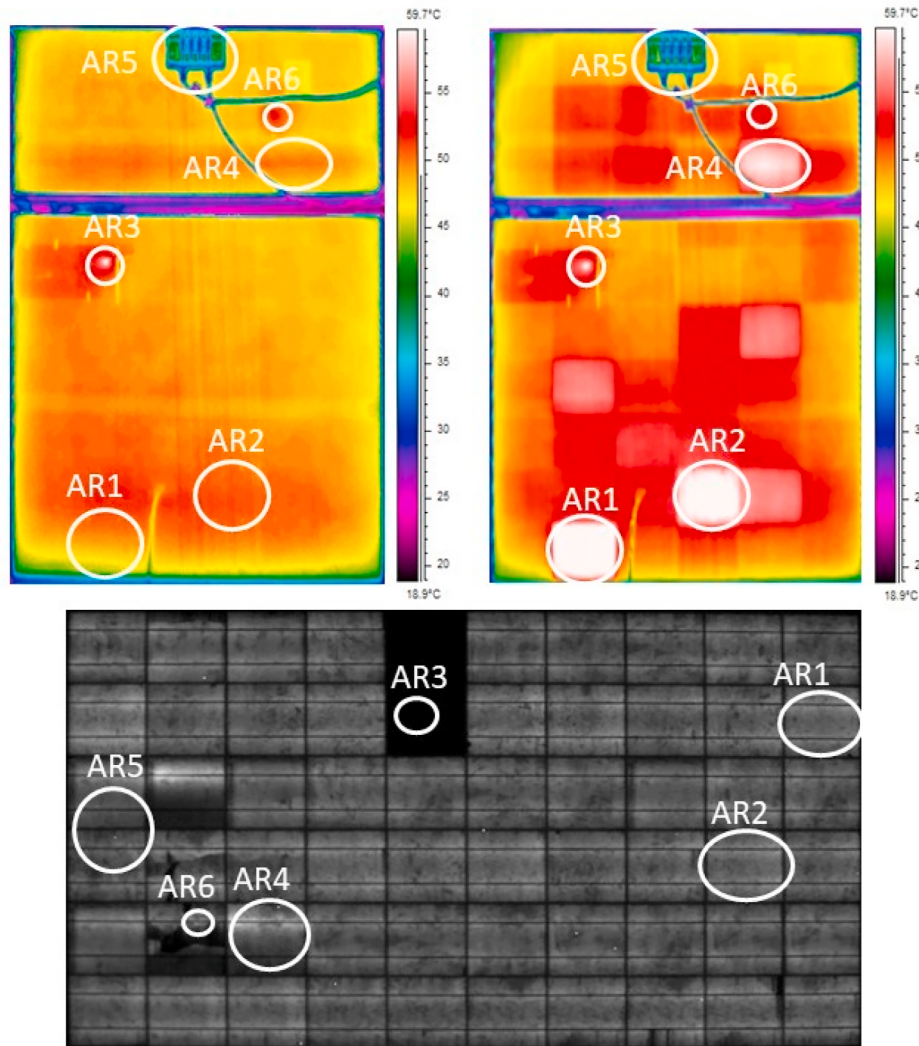
Infrared thermography images of module type B are given in Fig. 12, which shows the image captured in maximum point operating conditions and the image in short circuit conditions. The temperature gradient between the marked areas is presented and is consistent with the defects detected in this module. Note that AR03 sector is associated with a cell

**Fig. 12.** Images of IR thermography and EL of a module of type B show a maximum temperature difference of 11.2 °C between the marked regions temperature during the operating point and its temperature at short-circuit conditions.

that has deviated from its normal operation, which implies that the heat generated in this region does not originate from the intrinsic activity of the cell itself but is the result of the sum of heat transfers from both the front glass and the rear busbar, the latter soldered to repair and bypass the cell.

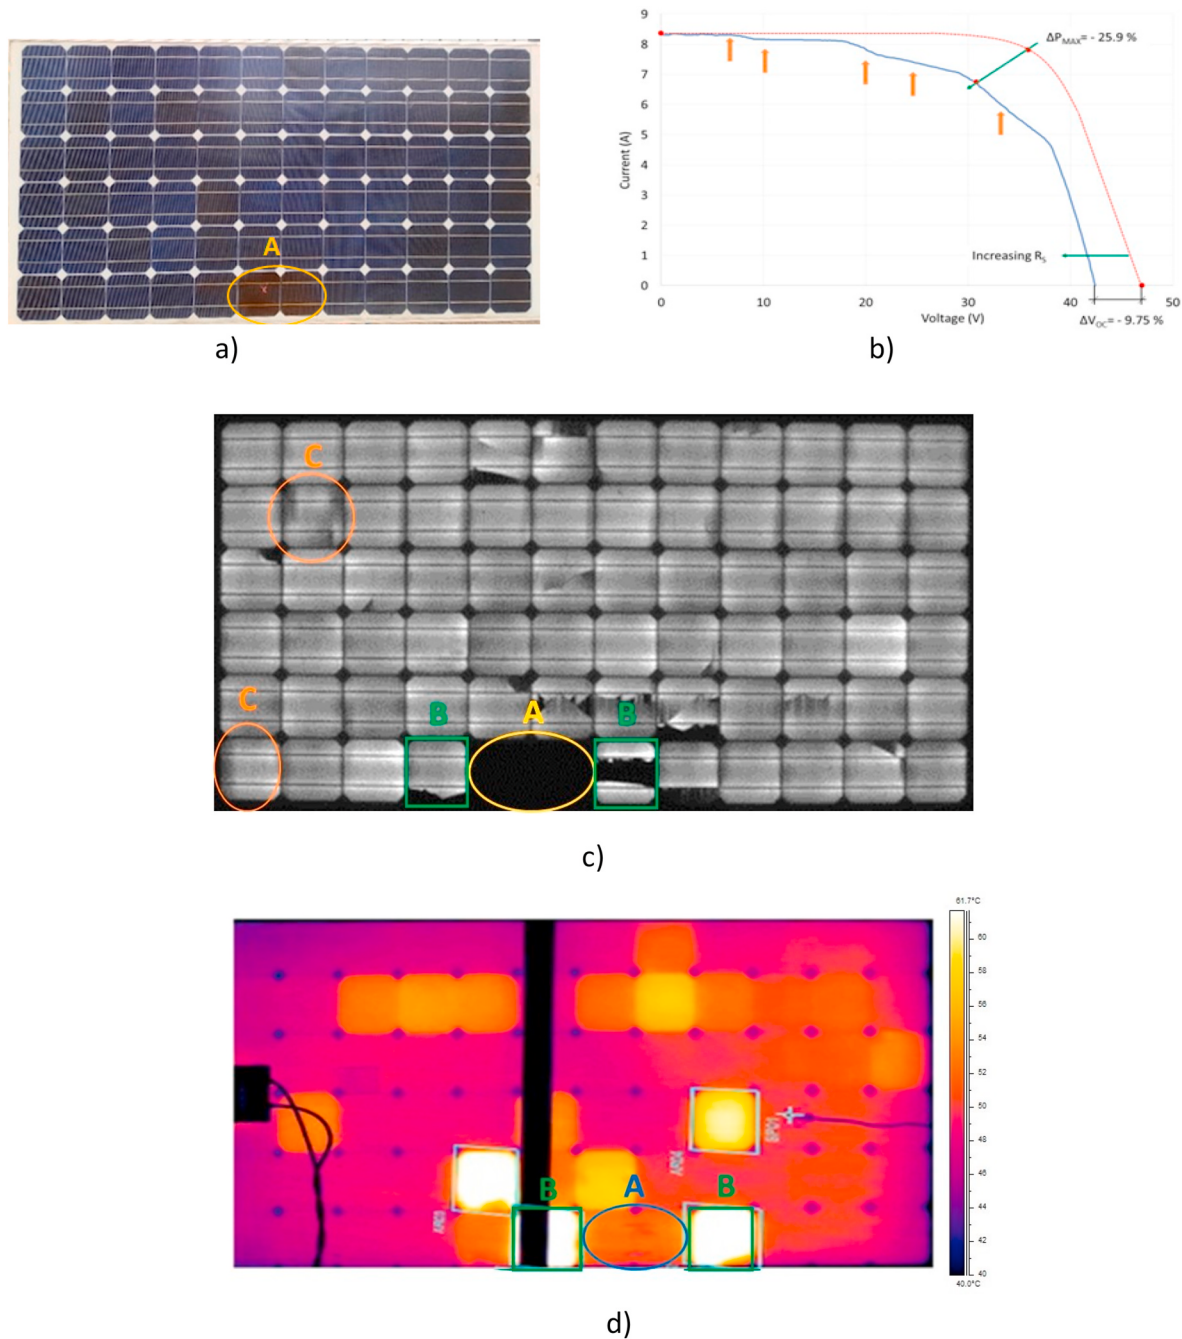
Fig. 13 presents a relation between the failures spotted in visual inspection, I–V measurement, EL, and IR images.

A decrease in open circuit voltage may be due to cell interconnection interruptions, cell cracks with isolated zones, or PID. Although the curve does not display a stepped evolution, an IR image indicates high temperature around the junction box, which suggests that the diode could be activated due to significant electrical mismatches of the cells evident in both the EL image and the I–V curve itself.

**Fig. 13.** a) Image captured during visual inspection of type C module showing browned and cracked cells, denoted by A. b) I-V curve with electrical degradation. c) Electroluminescence image exhibiting cracked cells, some denoted by B, MID, some denoted by C. d) IR thermography image presenting hotspots in the cracked cells, denoted by B.
