# Advances in the location and repairing of ribbon interruptions in photovoltaic modules

## ABSTRACT

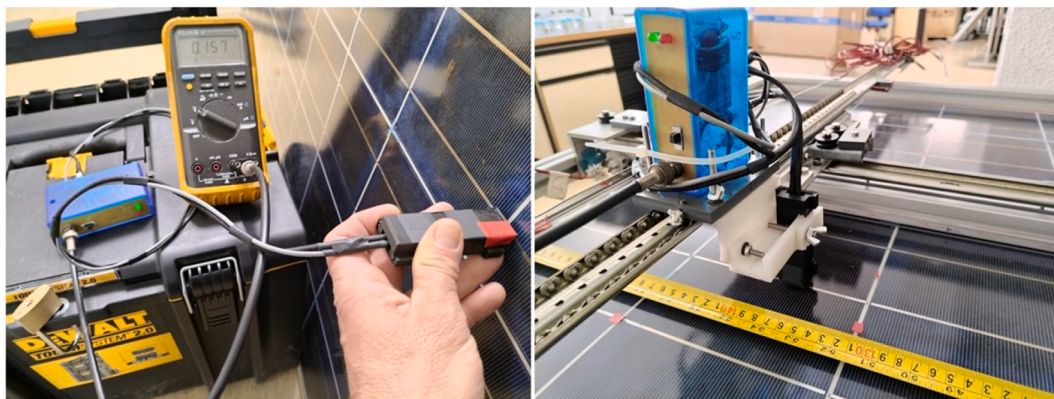
Fig. 1. On the left, the AMR sensor, its electronics and multimeter for recording the voltage output generated by the ribbon of a solar module, used as a portable device for detecting simple interruptions. On the right, the same sensor mounted on an XY frame with manual movement on the XY axes, placed on a solar module to record the magnetic signal along a ribbon of the module.

This section describes a method (Patent pending [15]) to locate simple interruptions between the solar cells of a module based on the Ørsted experiment [16] in which an electric current deviates the direction of a magnetic needle due to the magnetic field created by the current flowing in a conductor. This method is simpler, cheaper, reliable and equally fast or faster in addition to being easier to use than any of those described above. It does not cause damage to the back of the module, can be carried out in a real installation, with the only
