# Camera Based Reflector Degradation Detection

**Abstract.** Reflectors used in the solar fields of concentrated solar thermal technologies must maintain excellent optical properties over the lifetime of the commercial projects. However, the reflector materials are prone to degradation due to environmental stresses. Measurements with portable reflectometers are the state-of-the-art technique to evaluate degradation in the field, determining the most significant optical parameter, the reflectance. Some degradation mechanisms can evolve on reflectors in early stages without compromising reflectance, until they affect a large surface. This is why alternative measurement techniques are necessary. In this work, the development of an easy-to-use field measurement procedure for the degradation of solar reflectors is presented, which was investigated at the OPAC laboratory of the CIEMAT-Plataforma Solar de Almería (PSA). An automated image processing program has been developed, to determine the degraded area of reflectors based on various image sources. The capabilities to measure different scales of defect sizes on different reflector materials, with simple commercial camera equipment an

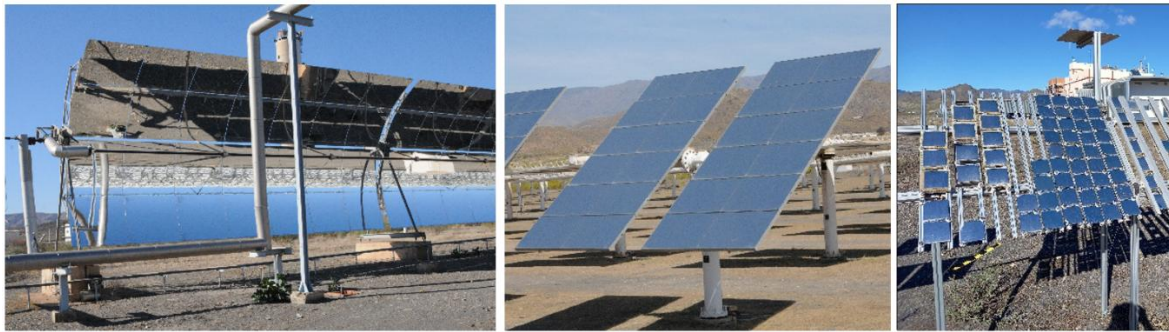
**Figure 4.** Reflectors used for the measurement campaign: left) PTC, middle) heliostat, right) sample exposure rack.

Three types of reflector materials are used to test the analysis with the here presented procedure. All materials are commercial or experimental 4 mm silvered-glass mirrors. The first set of pictures is taken on facets of a PTC (Figure 4, left). Some of the facets show widespread corrosion of the silver layer of varying degrees. Some facets show only beginning corrosion at the edges, and others show extreme corrosion covering important parts of the whole facet. The second set of images is taken on two heliostat facets (Figure 4, middle). These facets show a largely intact mirror surface with very localized degradation of various sizes, from millimetres to areas of tens of centimetres in diameter. Both these facet types have been exposed at the PSA for more than a decade and experienced the respective operational conditions, including realistic regular tracking of the collectors.

The third kind of material used are small reflector samples from different manufacturers, exposed on a specifically designed rack in a fixed position facing south with an inclination of  $45^\circ$  to the horizontal (Figure 4, right). These samples show localized corrosion spots with a maximum size of various millimetres, and some edge corrosion.

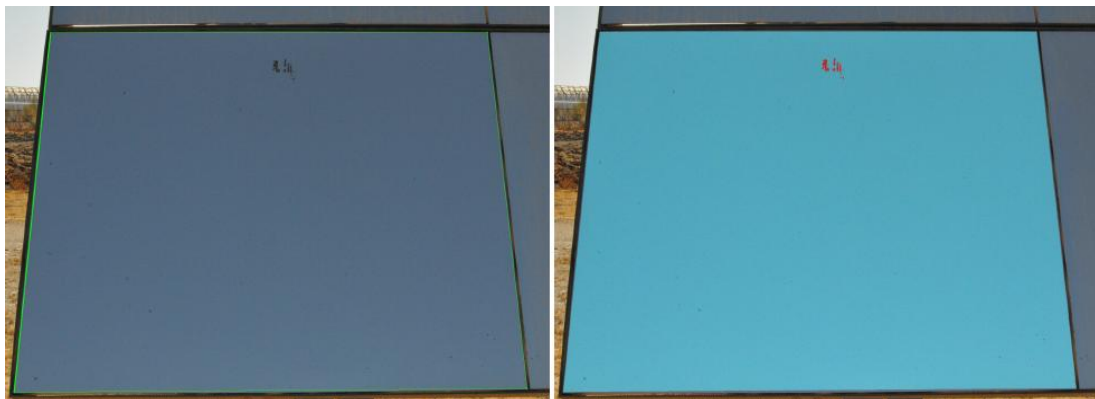
**Figure 6.** Images of one heliostat facet with well-defined corrosion: left) original image, right) after analysis, corroded area marked in red.

An example of the more common case of corrosion on silvered-glass reflector facets is displayed in Figure 6. Here, a facet is shown that presents a largely intact reflective area, with a relatively well-separated, corroded area in the upper part, close to the edge. On the left of the figure, the original image is shown and on the right, the output of the automatic analysis, with the corroded part in red. Qualitatively, the analysis is able to detect the degraded area.

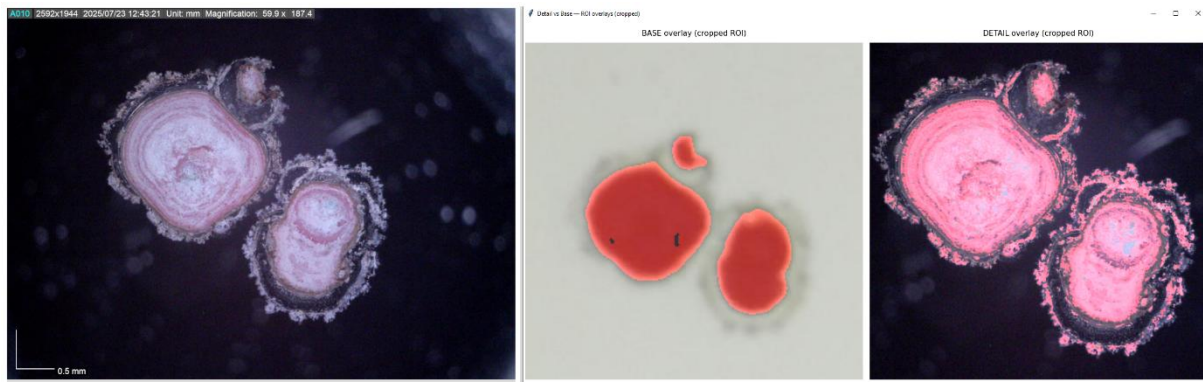
**Figure 10.** Left) microscopic image of selected corrosion spots of 10x10 cm<sup>2</sup> sample. Middle) zoom of analyzed degraded area on sample image. Right) analyzed area on microscopic image, corrosion marked in red.

In Figure 10 left, a microscopic image of these corrosion spots is presented with a magnification of 59.9x covering a total area of around 5x5 mm<sup>2</sup>. The analysis of this image (Figure 10 right) is compared to the zoom of the area of the total sample analyzed (Figure 10 middle). It can be seen that the degraded area on the microscopic image is detected successfully. The analysis of the full sample images detects the main spots, but does not identify the surrounding detached areas as corroded. This leads to an underestimation of the degraded area, similar to the case of the whole facet. The degraded areas are 4.55 mm<sup>2</sup> and 3.96 mm<sup>2</sup> for the microscope and camera image respectively, resulting in a difference of 13 %.
