# Failure Analysis of Steam Generator Tubes

*Gonzalo Diego and Susana Merino*

**Keywords:** steam generator (SG), denting, intergranular stress corrosion cracking (IGSCC), alloy 800, steam generator maintenance

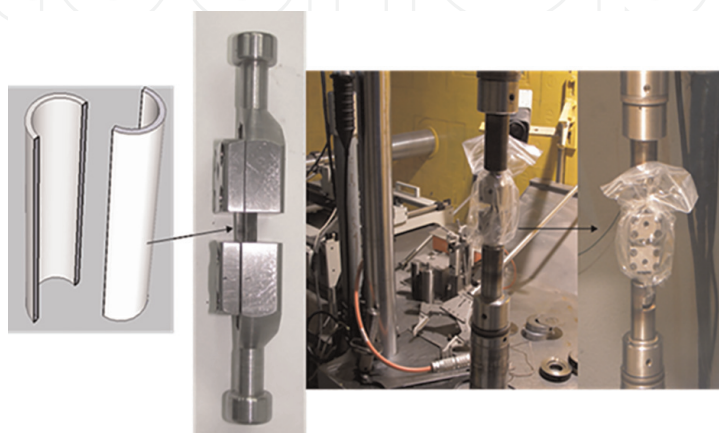
The characterization of the fracture surface was performed by longitudinally cutting the tube into two equal half parts. One of them was tested for fatigue to obtain the fracture surfaces (**Figure 3**).

**Figure 3.**  
*Devices used to obtain the fracture surface.*

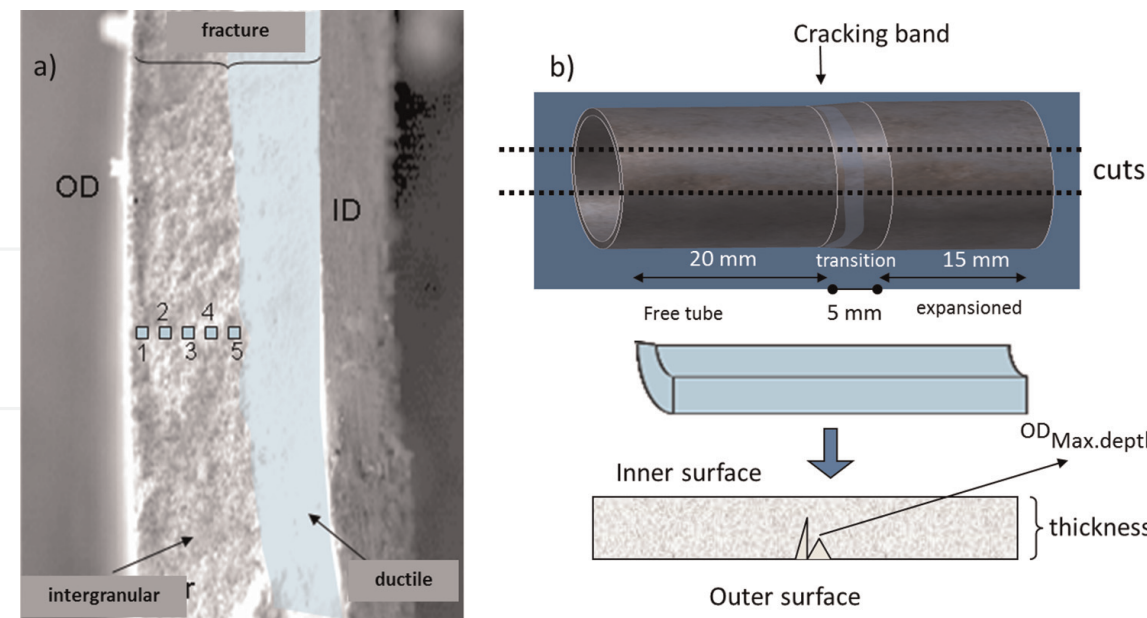
The fracture surface was examined on SEM to quantify the length and depth of existing cracks. The deposits found on the fracture surface of the two cracks were analyzed by EDX and by Auger spectroscopy, five zones of each crack from OD, (point 1) to inside the crack (point 5) (**Figure 4a**).

Metallographic characterization of the axial sections was carried out on the other half of the tube piece as shown in **Figure 4b**.

**Figure 4.** a) Points analyzed on the fracture surface by Auger spectroscopy. b) Metallographic specimens from the other half of the tube in the area of interest.

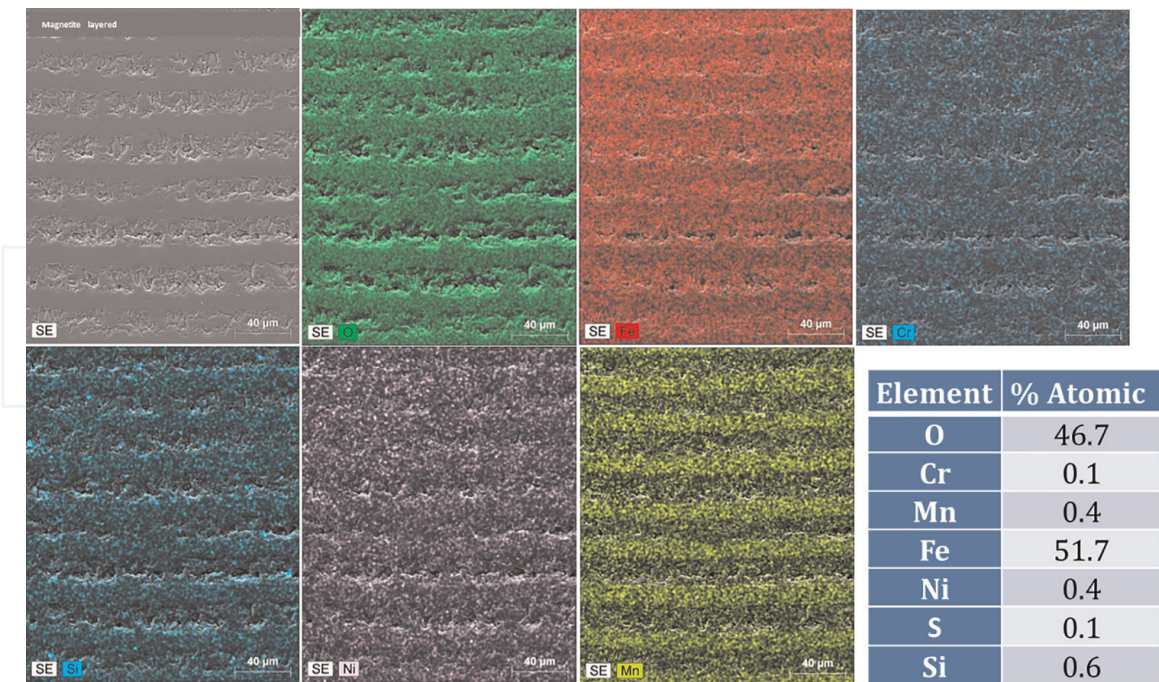
**Figure 14** shows the elemental distribution on the magnetite layers with enriched bands in Mn. Dot analysis shows only Fe and O in the compact layers while in the porous layers exists an enrichment of Mn, Ni, Si, and other elements in a lower concentration (**Figure 15**).

**Figure 14.**  
*Mapping of elements distribution in the cross-section of magnetite layered.*

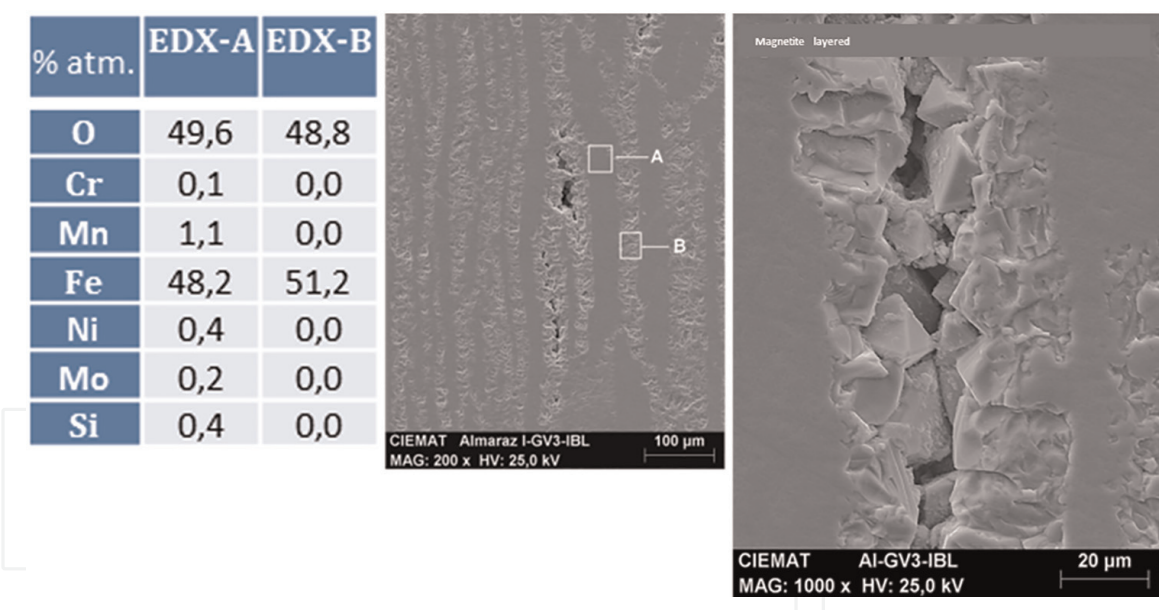
**Figure 15.**  
*Dot EDX analysis in the cross-section of magnetite layered sample.*

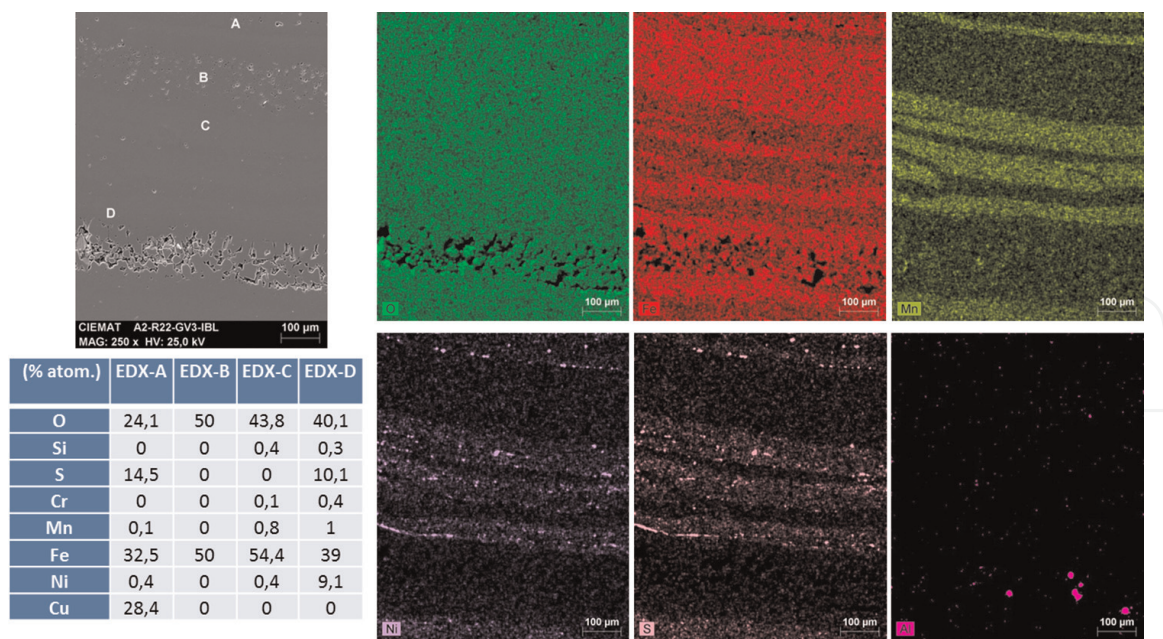
The total of these elements forming the enriched bands is only 2%, the rest is Fe and O. Additional analyses performed detected an increase in S and Ni with isolated precipitates of Cu (**Figure 16**).

**Figure 16.**  
*Mapping of elements distribution in the cross-section of Magnetite layered.*

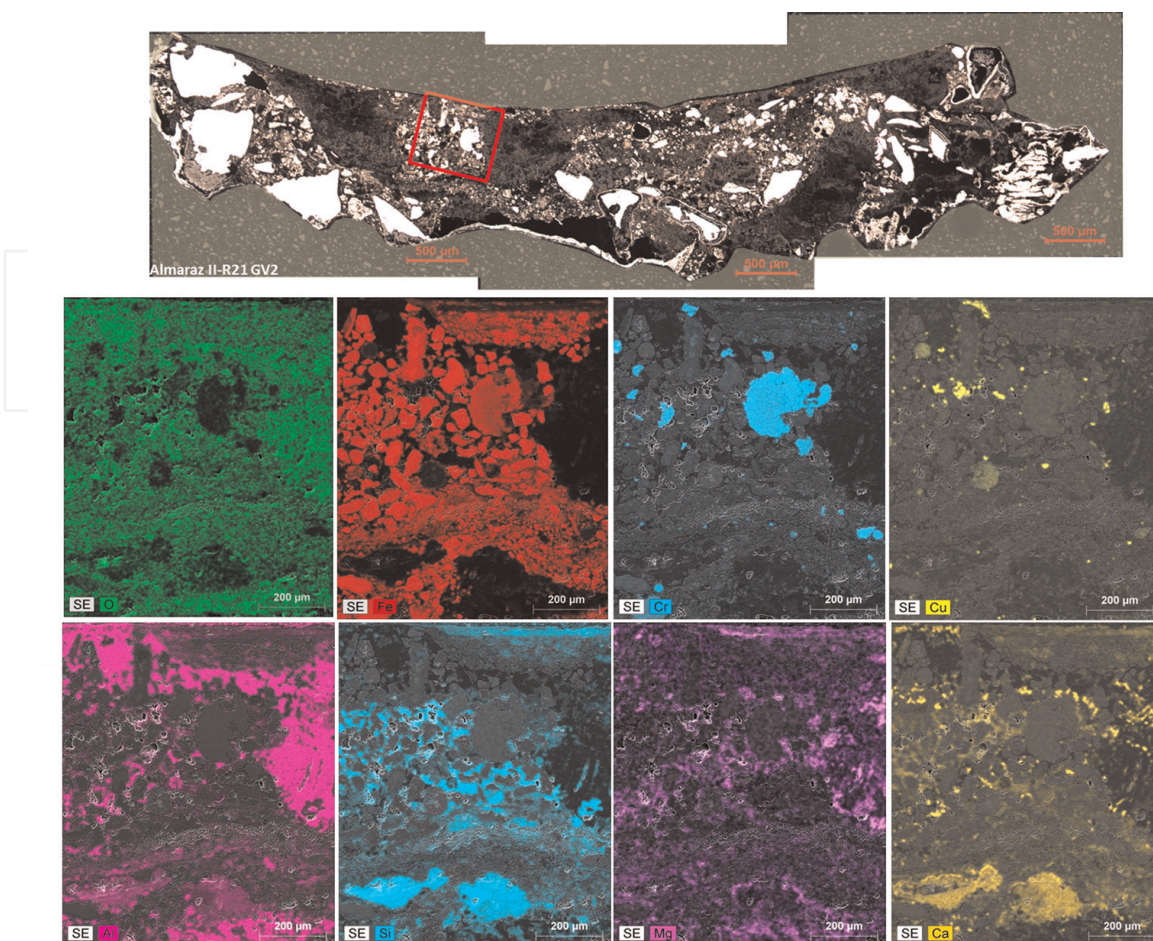
As discussed at the start of this section, “collars” pieces were detected Spanish NPPs (**Figure 17**). Cross-sections of these samples are formed by a number of metallic inclusions embedded in a matrix of Al and Si species (**Figures 18 and 19**). These last elements were enriched preferably near the interface with SG tube surface. Si/Al ratio is higher when the silicates are the binding agents.

**Figure 18.**  
Cross-section collar. Spatial distribution of chemical elements by SEM-EDX.

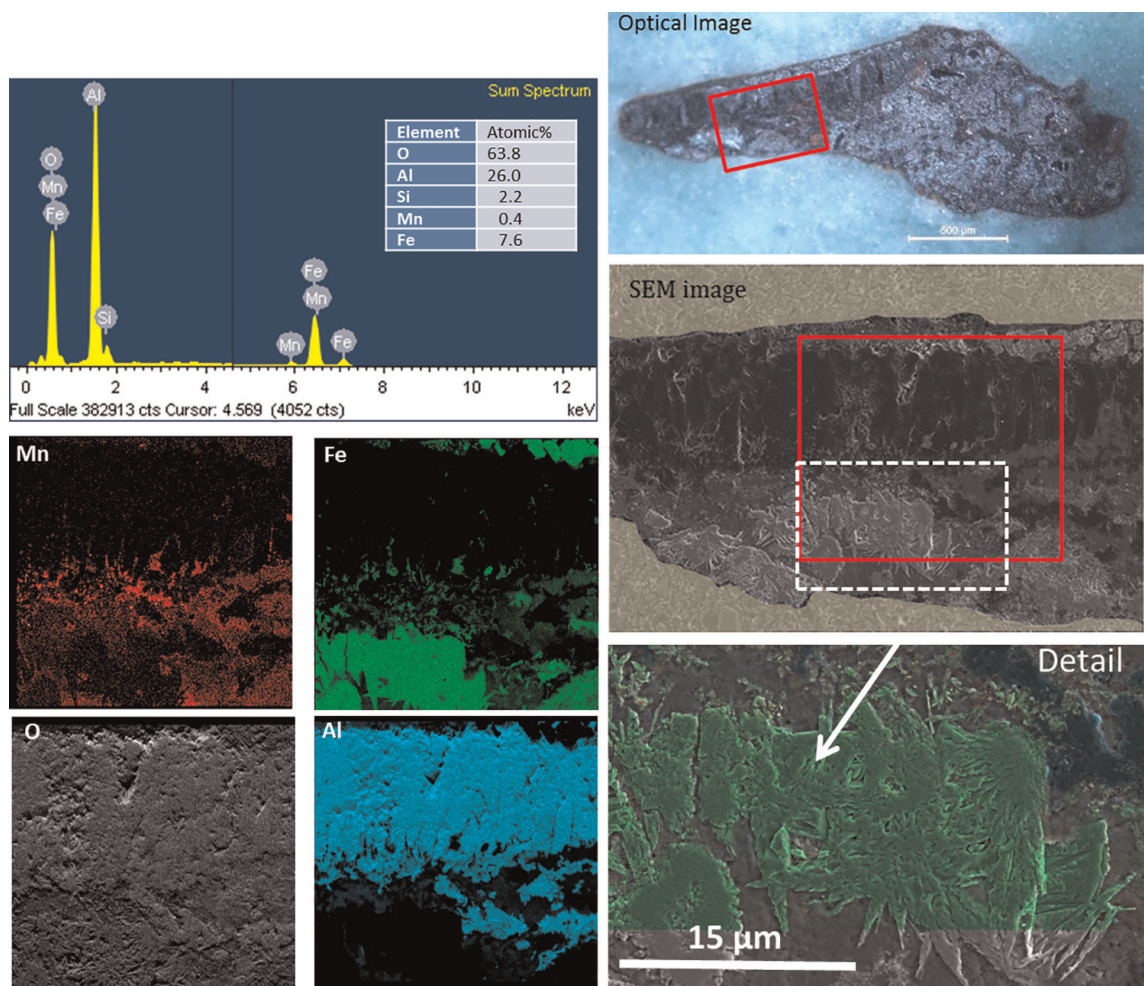
**Figure 19.**  
*Cross-section collar. Spatial distribution of chemical elements by SEM-EDX.*

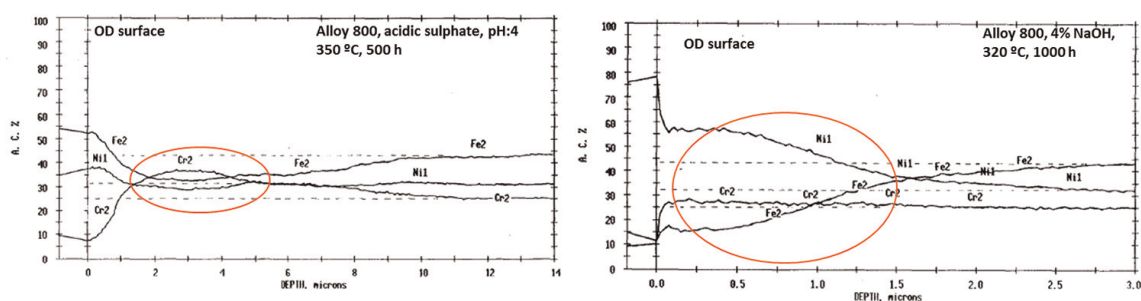
The results of the EDX analyses and Auger analyses carried out on the fracture surfaces of cracks A and B allow us to infer the medium in which the cracks have been formed. For this purpose, the concentration profiles obtained on cracks A and B with those obtained on samples tested in the laboratory were compared (**Figure 21**). In acidic media, a first layer rich in iron and nickel is observed, which is identified as a layer deposited on the specimen during cooling, and below it a layer with enrichment in chromium and depletion in nickel and iron is visible. In caustic media, an oxide

**Figure 21.**  
 Auger analyses. Concentration profile of deposits formed on the external surface of a C-ring specimen tested in acid sulfates at pH =4 at room temperature and in caustic media.

layer with clear nickel enrichment, slight chromium enrichment in its outermost part, and iron impoverishment is observed.

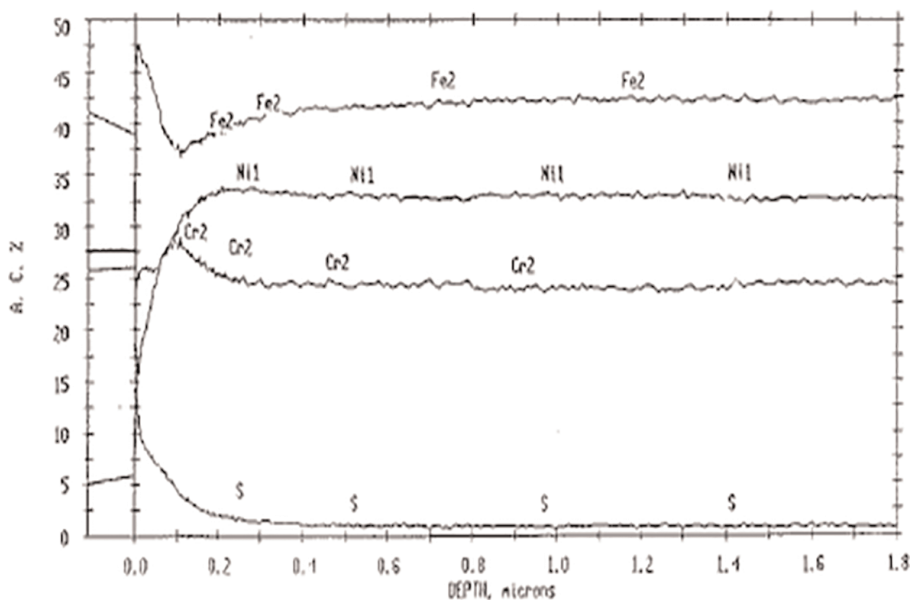
**Figure 22** shows the concentration profiles obtained on the crack fracture surface formed in an Incoloy 800 tube tested in a “model boiler” in the laboratory, in acid sulfate media, with pH=4, at room temperature.

If we compare these results with the concentration profiles obtained at the bottom of cracks A and B (**Figure 21**), we observe that the main difference between these curves and those of the laboratory sample is the existence of nickel enrichment in the latter, which, as shown in **Figure 23**, is the typical trace left by alkaline environments.

Therefore, we can conclude that the cracks have been formed in a neutral or slightly alkaline environment. Alkaline environments with pH> 10 can be discarded due to the presence of silicates. Sulfur presence would suggest acidic environments, although this evidence is not fully conclusive in all performed analyses. However,

**Figure 22.**  
Auger analyses. Concentration profiles of the oxides at the bottom of a crack in an Incoloy 800 tube were tested in a model boiler in acid sulfate media.

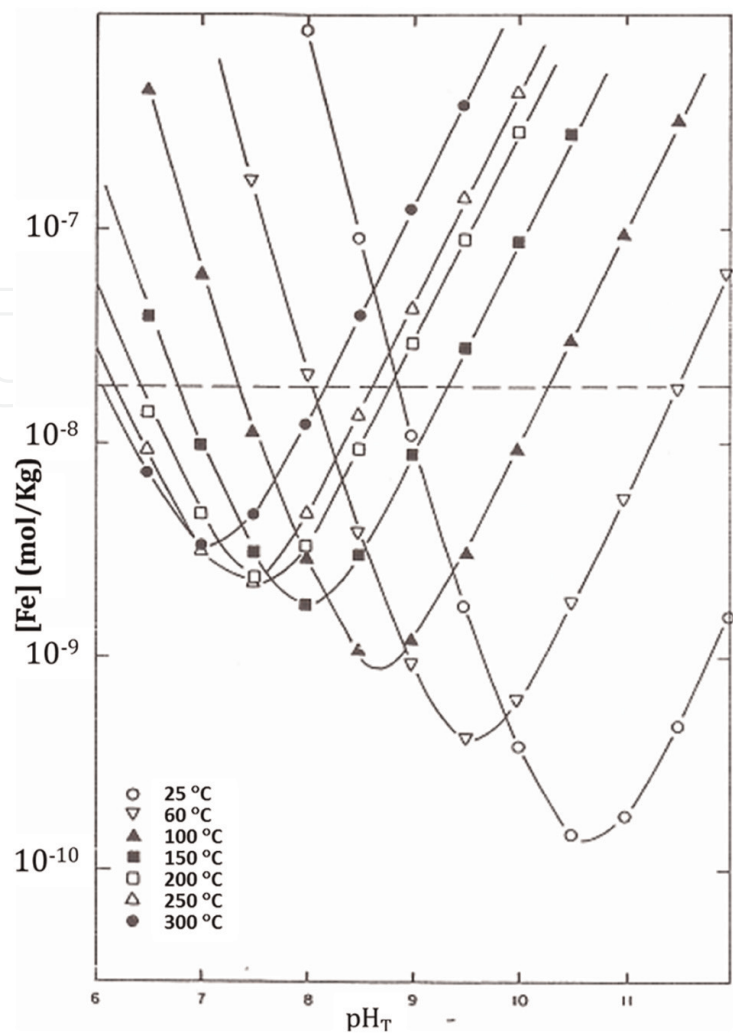
Magnetite solubility is very strongly dependent on both pH and temperature (**Figure 24**). For 300°C there is a minimum in solubility (about  $5 \cdot 10^{-9}$  M) found at about pH<sub>300</sub>=7. However, the solubility increases one order of magnitude with the change of one unit of pH at 300°C in both directions [21]. As a rule, the magnetite solubility presents a minimum value for each temperature and pH, diminishing for lower temperatures and higher pH. This is why efforts to avoid the deposition of magnetite by ETA injection before shutdown and, thus, reduce the magnetite solubility and FAC. Obviously, if the amount of iron in solution is high the magnetite deposition will occur during the shutdown, especially in the cold legs. Magnetite layer is formed by a competitive process between deposition and solubility due to the small variations around this minimum of the solubility.

A protective layer of magnetite can increase during normal operation of the plants, by these previous arguments, up to a certain thickness from which magnetite layer spallation is produced. This would explain the structure found in samples named magnetite layered where alternate layers are formed during the oxidation process of low carbon steels (tube sheet). A first oxide layer is initially composed mainly of iron and oxygen and other alloying elements that depending on their different diffusion coefficients will form enriched layers in the oxide microstructure. The thickness of this first oxide layer can increase during operation up to a limit depending on several factors: temperature, environment, and time. This process will lead to a rise in the stress between a metal surface and oxide layer. When the stress in the scale increases to the limit accommodated by elastic strain, it will deform or fracture. The spallation of the scale removes its protective function allowing direct access of the environment to the metal beneath and leads to a rapid increase in oxidation forming a second oxide layer. During the oxidation, the stresses can grow due to the different specific volumes of the oxide and the volume of the metal being consumed in the reaction, which can also be influenced by specimen geometry. Moreover, thermal stresses caused by differential thermal expansion or contraction in the oxide and the substrate during temperature change can also lift the oxide layer. FFA additions can increase the

**Figure 24.**  
*Calculated solubilities of magnetite as a function of pH over the temperature range 25°C–300°C.  
 $p\{H_2\} = 1 \text{ atm}$  [20].*
