# Enhancing photovoltaic module sustainability: Defect analysis on partially repaired modules from Spanish PV plants

M.B. Nieto-Morone<sup>a,b,\*</sup>, F.G. Rosillo<sup>a</sup>, M.A. Muñoz-García<sup>b</sup>, M.C. Alonso-García<sup>a</sup>

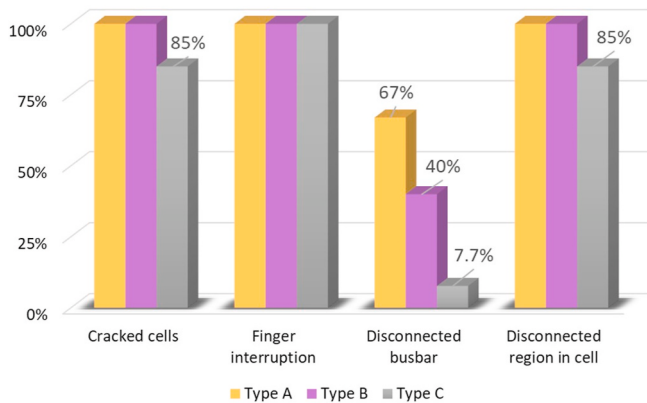
Other failures, such as finger interruptions, cell cracks and short-circuited busbars, were also detected using electroluminescence imaging because of the reduced luminescence from these defective areas. Fig. 7 presents the results we obtained after analysing the modules of the three types of modules.

**Fig. 7.** Percentage of modules affected by the defects revealed in the electroluminescence images. Bars without labels have a failure occurrence rate of 100 %.

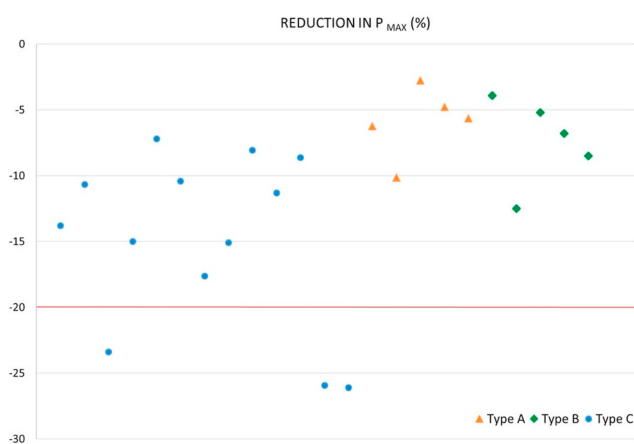
Fig. 16 shows that type C modules have the largest power loss. Even those not exceeding the –20 % threshold show a greater dispersion than the remaining types A and B. Modules of types A and B show lower power losses, with a maximum power loss of 12.5 % for type B.

Analysing the power reduction in the complete set of modules, our results show that despite the presence of defects, around 87 % of these modules exhibit a power reduction of less than 20 %, as depicted in Fig. 16.

Fig. 16. Analysis of Maximum power reduction of the 23 partially repaired modules.

In terms of the type of defect with the highest frequency of occurrence across the three module types, our results indicate that moisture-induced degradation (MID) is the most common defect, followed by cracked cells and disconnected areas in cells. However, despite the presence of defects, around 87 % of these modules exhibit a reduction of less than 20 % in power.
