Ultrasonic techniques for quality assessment of ITER Divertor plasma facing component

Rafael Martínez-Oña ^{a,*}, Mónica García ^a, Mercedes Medrano ^b

^a Tecnatom, 28703 S. Sebastián de los Reyes, Madrid, Spain

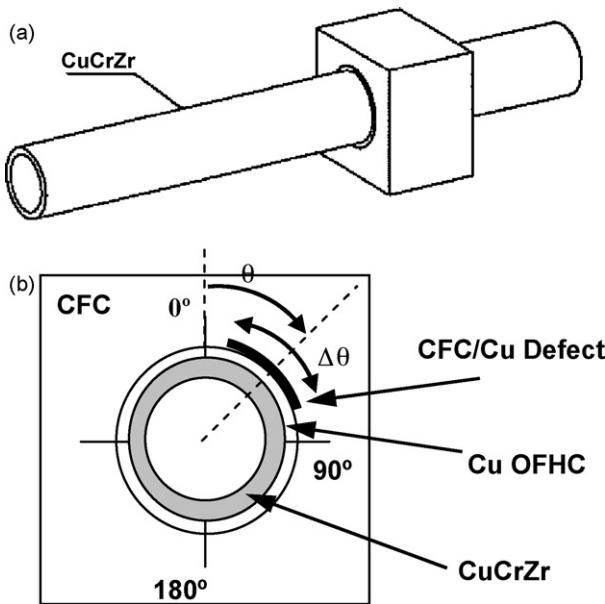
Fig. 1. CFC monoblock (a) mock-up geometry and (b) defect parameters.

Three types of mock-ups, manufactured by two different technologies, have been considered: CFC monoblocks, W monoblocks, and W flat tiles. The mock-ups of the two first sets are made of a monoblock, in one case of CFC and in the other of W, and a piece of Cu alloy tube joined together by means of two joints: CFC/Cu or W/Cu and CuCrZr/Cu (see Fig. 1). Each sample has a defect

implanted either in the first (CFC/Cu or W/Cu) or in the second (Cu/CuCrZr) joint. Regarding circumferential location (θ) the defect could be placed in a range: -45° to $+45^\circ$ and its size ($\Delta\theta$) varies from 15° to 65° ; the definition of defect location and size is shown in Fig. 1.

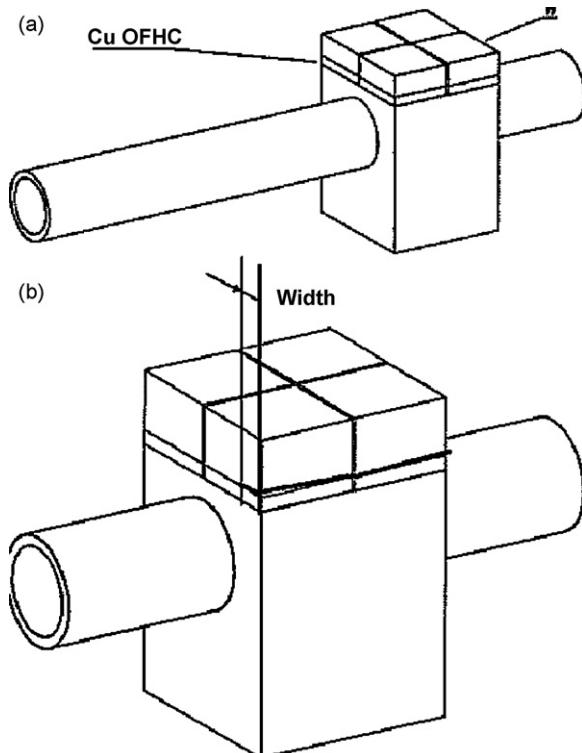
Fig. 2. W flat tile (a) mock-up geometry and (b) defect width.

The W flat tiles samples have a similar morphology to those above: a piece of tube with a monoblock of Cu alloy with four W tiles joined to one of the faces of the monoblock by means of a pure copper layer being those the joints examined (see Fig. 2). Each sample has a defect of different size (from 2 to 6 mm) implanted either in the first (W/Cu) or in the second (Cu/CuCrZr) joint.

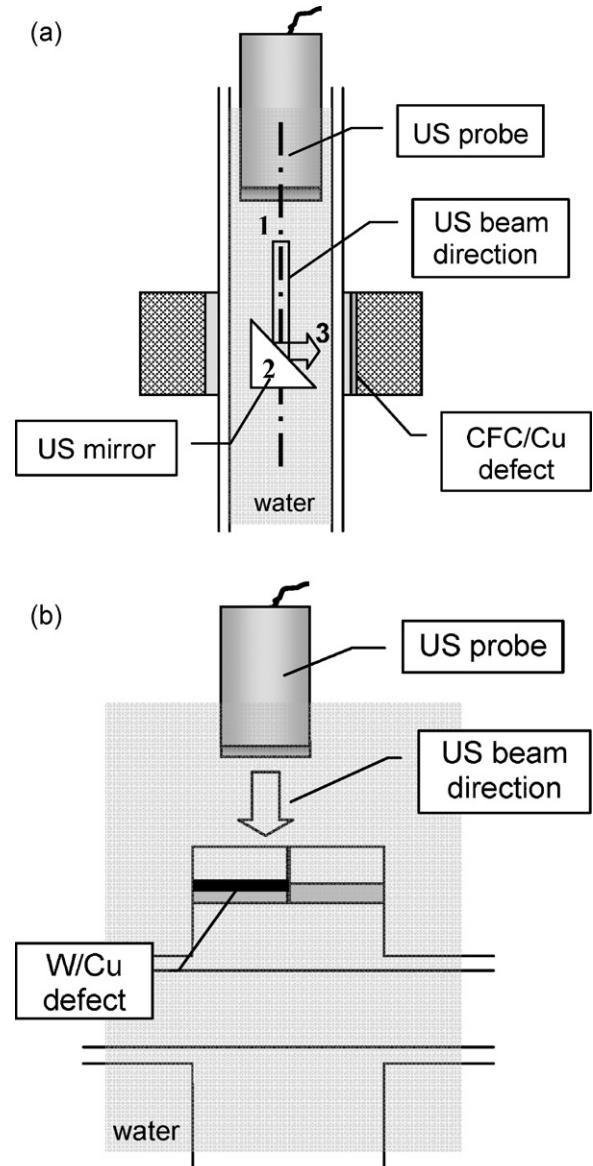
Fig. 3. Principle of ultrasound method for (a) monoblocks and (b) flat tiles.

In order to design the inspection technique it is necessary to know the geometry of the mock-ups, their materials and the characteristics of calibrated defects. An ultrasonic method using high frequency probes (of 5 and 10 MHz) and normal incidence of the US beam (to the joint interface) have been developed; it is named pulse echo because the transducer acts as emitter and receiver. The examination of the monoblock samples is made from inside the tube, and the examination of the W flat tile samples is made pointing the US beam to the tiles from outside the mock-up (see Fig. 3).

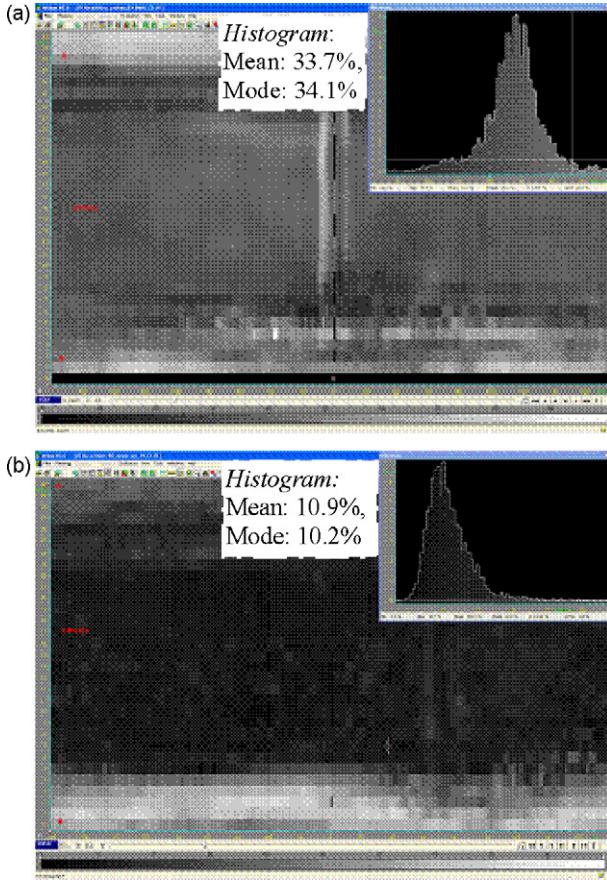
Fig. 4. C-scan and amplitude histogram of a CFC monoblock sample (a) before and (b) after HHF test. Amplitude scale appears horizontally at the bottom of each C-scan; black colour means the lower amplitude value and white colour means the higher amplitude value. Higher amplitudes appear before the HHF than after the HHF.

The increment of US attenuation after the HHF tests could be seen comparing the C-scans and the amplitude histograms of a same monoblock mock-up, examined applying the same calibration, before and after the HHF test. The images show that after the HHF test (Fig. 4b) the amplitudes of the received signals are smaller than the amplitudes before the HHF test (Fig. 4a); the C-scan before the HHF contains more pixels above the recording level than the C-scan after the HHF, and the amplitude histogram peak before the HHF has a higher amplitude than the amplitude histogram peak after the HHF.

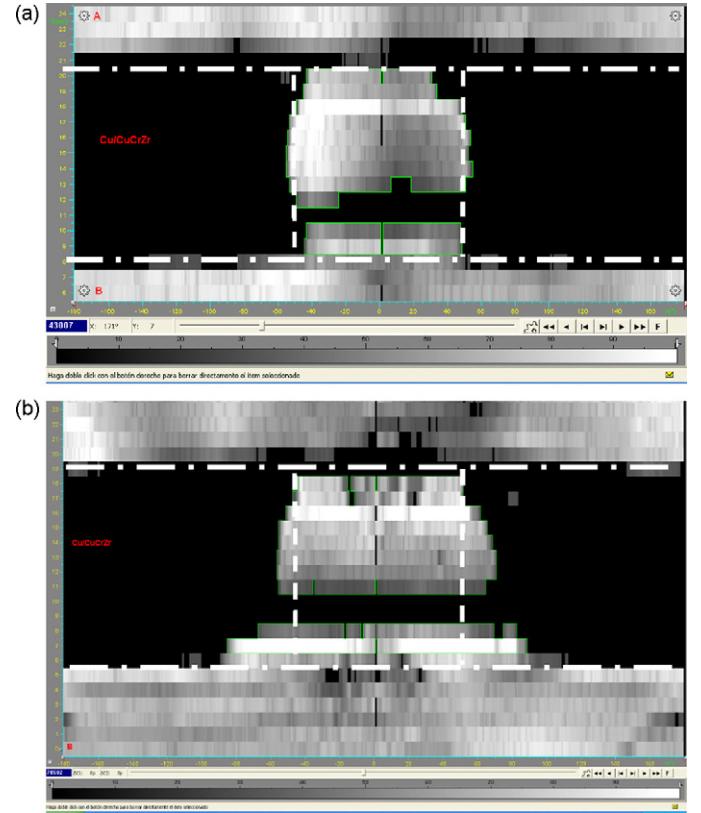
Fig. 5. US C-scan of a W monoblock Cu/CuCrZr joint (a) before and (b) after HHF test. Horizontal axis represents circumferential coordinate and vertical axis axial coordinate. Grey and white pixels represent points of monoblock with amplitudes above the analysis threshold; at the centre of the image is the defect, the pixels at the upper and lower borders correspond to tube wall. Area between the horizontal dash dotted lines indicate the zone of interest; area between the vertical dashed lines mark the postulated defect area. Defect size after the HHF is larger than before the HHF.

Two sets of 28 samples each and fabricated by two different manufacturers have been examined. Each set has 14 samples with defects in the W/Cu joint and another 14 samples with defects in the Cu/CuCrZr joint. The US method was able to detect, locate and size all the implanted defects; in one of the sets, the US measurements are in agreement with the specified defect sizes (see Fig. 5a),

uation and, on the other, damage in the defect that enlarged its size (see Fig. 5a). The US method was able to detect and locate all the implanted defects. The defect sizes have also been measured and in all the cases but one they have increased.

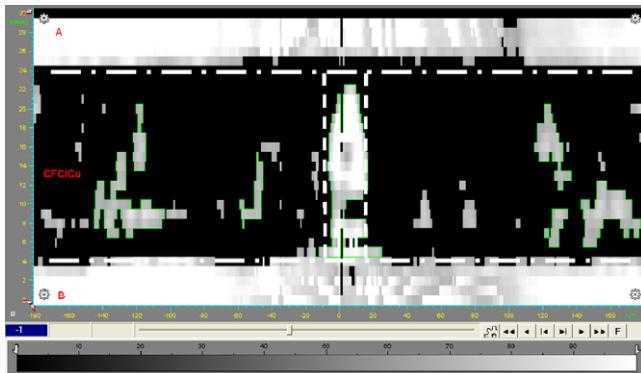
Fig. 6. US C-scan of a CFC monoblock CFC/Cu joint C-scan (a) before and (b) after HHF test. Horizontal axis represents circumferential coordinate and vertical axis axial coordinate. Grey and white pixels represent points of monoblock with amplitudes above the analysis threshold; at the centre of the image is the defect, the pixels at the upper and lower borders correspond to tube wall, and the pixels around the defect are spurious indications. Area between the horizontal dash-dotted lines indicate the zone of interest; area between the vertical dashed lines mark the postulated defect area.

(see Fig. 6). Stop-off defects are defects implemented by preventing the wetting of CFC surface by local lack of pre-brazed casting alloy and by a stop-off coating for defects at W/Cu and Cu/CuCrZr interfaces [4].

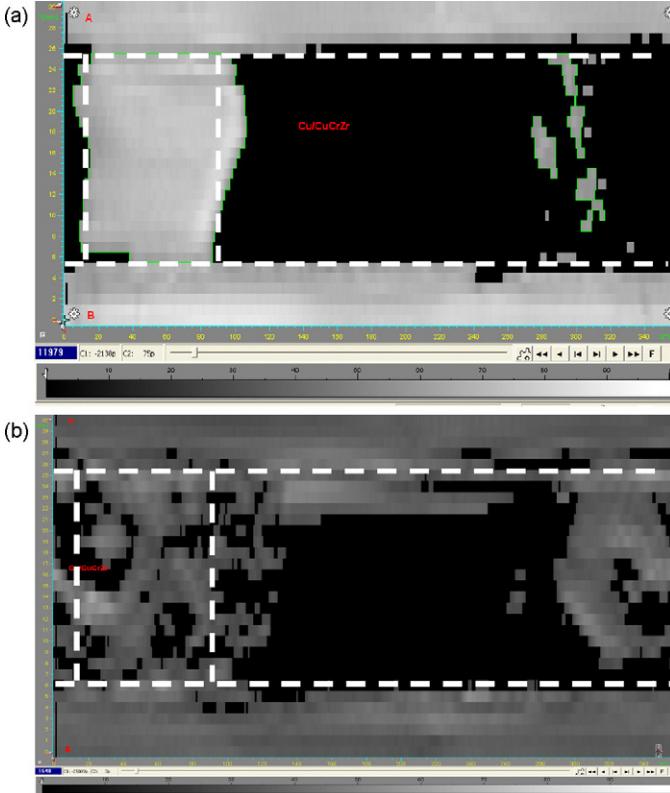
Fig. 7. US C-scan of a CFC monoblock Cu/CuCrZr joint C-scan (a) before and (b) after HHF test. Horizontal axis represents circumferential coordinate and vertical axis axial coordinate. Grey and white pixels represent points of monoblock with amplitudes above the analysis threshold; to the left of the image is the defect, the pixels at the upper and lower borders correspond to tube wall, and the pixels to the right side correspond to a new indication. Area between the horizontal dash dotted lines indicate the zone of interest; area between the vertical dashed lines mark the postulated defect area. Defect size after the HHF is larger than before the HHF and reveals the anisotropy of joint materials.

Two sets of more than 24 samples each one and fabricated by two manufacturers have been examined. Half of the samples have defects in the Cu/CuCrZr joint and the other half have defects in the CFC/Cu joint. In the Cu/CuCrZr joint all defects have been detected, located and properly sized (see Fig. 7a). In the CFC/Cu joint, for the machined defect samples all defects have been detected and properly measured and, however, for the so called stop-off defect samples the 70% of the defects have been detected due to a low signal to noise ratio and spurious signals coming from the CFC structure produced by the anisotropy of the CFC and the significant acoustic impedance difference between the Cu and the CFC [5]

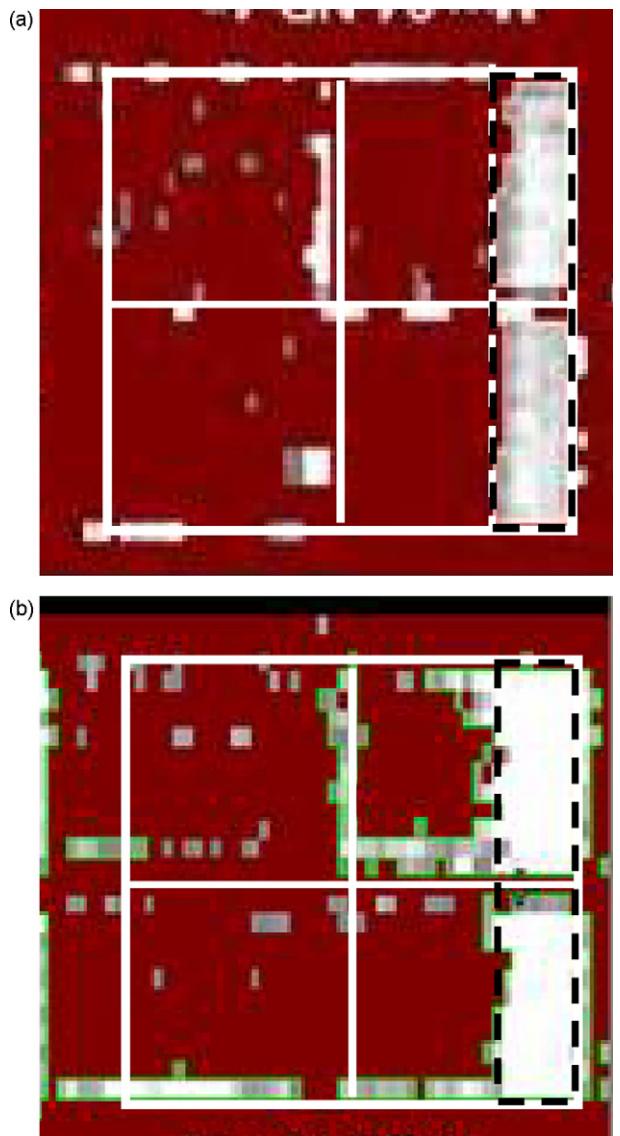
Fig. 8. US C-scan of a W flat tile W/Cu joint C-scan (a) before and (b) after HHF test. Solid lines indicate the four tiles, dashed lines mark the postulated defect area. Horizontal axis corresponds to the monoblock width and vertical axis to monoblock height. Grey and white pixels represent points of monoblock with amplitudes above the analysis threshold; to the right of the image is the defect, scattered pixels are spurious indications. Defect size after the HHF is slightly larger than before the HHF.

Two sets of 14 samples each, fabricated by two manufacturers, have been inspected. Half of the samples have defects in the W/Cu joint and the other half in the Cu/CuCrZr joint. The good signal to noise ratio and the high resolution of probe movements allowed obtaining detailed C-images. In both joints, W/Cu and Cu/CuCrZr, all the defects have been detected, located and measured their sizes. These measurements are in accordance with the specified defect sizes (see Fig. 8a).
